Certain 2010 Model Year 4WD Tacoma Vehicles
Front Propeller Shaft Safety Recall
*****URGENT*****

Subject: Safety Recall – A0D
Certain 2010 Model Year Tacoma 4WD Vehicles
Front Propeller Shaft Inspection

TECHNICAL INSTRUCTIONS
FOR
SAFETY RECALL A0D
FRONT PROPELLER SHAFT INSPECTION
2010 MODEL YEAR TACOMA 4WD

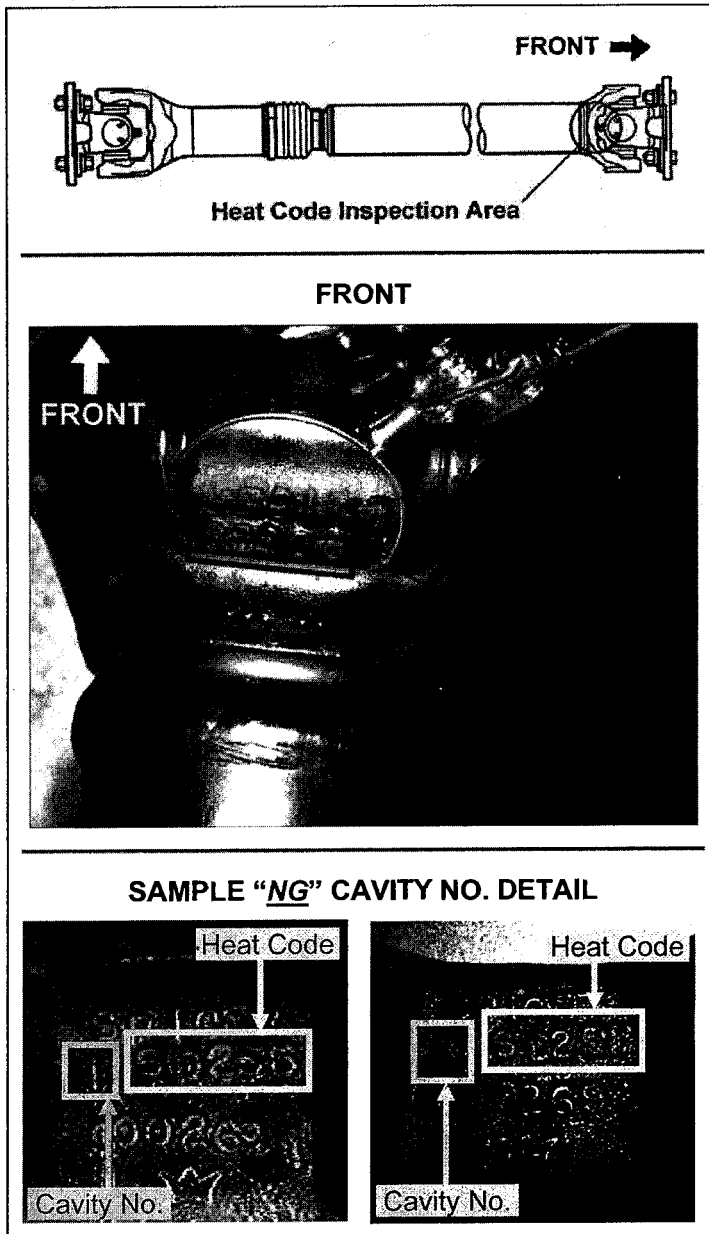
A. INSPECT THE FRONT PROPELLER SHAFT

1. CONFIRM THE HEAT CODE AND CAVITY NO.

- a) Using a telescoping mirror and flashlight, locate the 5 digit Heat Code and 1 digit Cavity No. stamped on the front end of the front propeller shaft as shown in the illustrations.

The front propeller shaft is NG / affected, Proceed to APPENDIX "A" for "FRONT PROPELLER SHAFT REPLACEMENT".

- a) Replace the "**Front Propeller Shaft**" and install a **NEW** one as outlined in the repair manual (TIS keyword: "Front Propeller Shaft Assembly".)
- b) Campaign completed
