**Re: Defect Information Report – Supplemental Report No. 3  
11V-109, FL-589  
AirLiner Mono Leaf Suspension Springs**

## Subject: AirLiner Mono Leaf Suspension Springs

July 2011  
FL589A  
NHTSA #11V-109  
Transport Canada #11-075

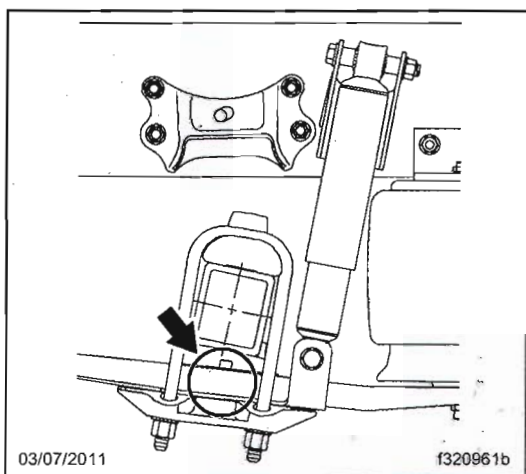
Fig. 1, Spring Inspection

Certain vehicles may have been built with rear suspension springs that may fracture through the center bolt hole after assembly. Less than optimal springs and installation procedures for the axle clamp group at the Cleveland manufacturing plant may result in hydrogen induced or assisted cracking. If undetected, over time the rear end of the spring may separate from the vehicle, resulting in a hazardous road debris situation, increasing the risk of a crash. Less than 2 percent of springs are expected to need replacement.

1. Clean all road grime and grease from the surface of the rear suspension springs in the area around the U-bolts. See Fig. 1.
2. Inspect the surface of the spring between the U-bolts for cracks. Use a flashlight and an angled mirror to inspect the outside surface of the spring.
3. If cracks are visible, replace the spring using the spring replacement procedure below.

If no cracks are visible, torque the U-bolt nuts to 420 to 500 lbf-ft (571 to 680 N-m), following the sequence shown in Fig. 2.

4. Repeat the inspection of the surface of the spring.

If no cracks are visible, no further work is needed. Clean a spot on the base label (Form WAR259) and attach a completion sticker for FL589 (Form WAR260) to the base label.

If cracks are visible, replace the spring, using the spring replacement procedure below.
