TOYOTA CUSTOMER SERVICES

Volume: XVI
Number: TC10-030
Date: 06/08/2010
 Action
 Retain
 Information

Subject: Safety Recall – A0G
Certain 2003 Model Sequoia Vehicles
Vehicle Stability Control System, Skid Control ECU Update

TECHNICAL INSTRUCTIONS
FOR
SAFETY RECALL A0G
SKID CONTROL ECU CALIBRATION UPDATE
2003 MODEL YEAR SEQUOIA

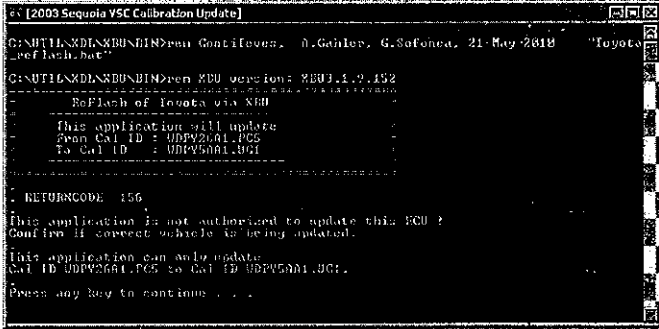
RETURNCODE 156: Wrong Calibration ID Number:

This Skid Control ECU is not part of this safety recall.
