To: All Subaru Dealers
Attn: Service Manager
From: Subaru of America, Inc.
Date: May 18, 2010

Subject: Update - Subaru Recall WVQ-27
2010 Legacy/Outback CVT Transmission Fluid Cooler Inlet Hose

Subject: Inspection and Replacement Procedure for CVT Transmission Fluid Inlet Cooler Hose

Affected Models: 2010MY Legacy and Outback; Equipped with CVT

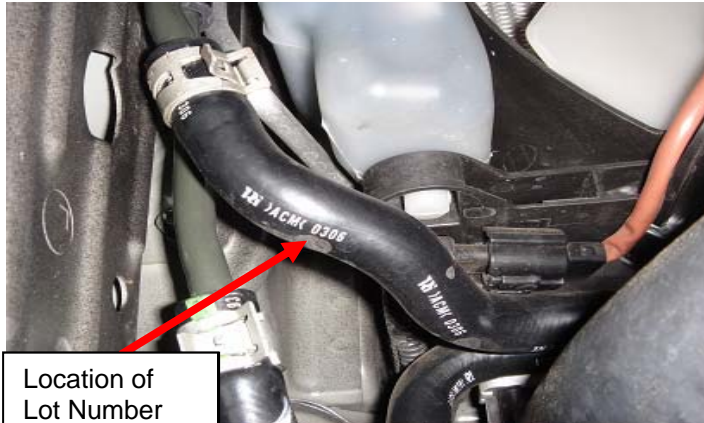
The lot number is stamped on the hose with white paint.

The lot number can be viewed with the hood opened, or with the vehicle on a lift.

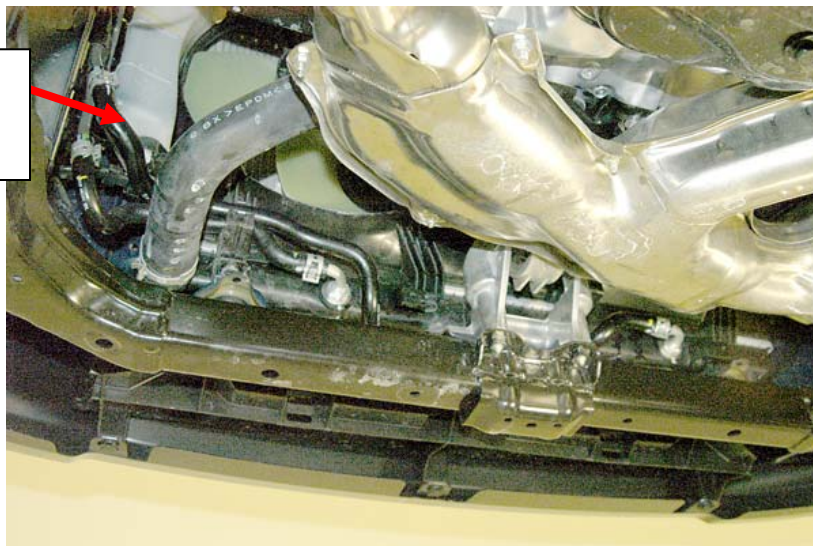
Continuously Variable Transmission Cooler Hose

Hose Location:
The hose affected is the longer of the two.
