**Re: Defect Information Report – Supplemental Report No. 4
10V-249, FL-580,
Sterling 360 Anti-Lock Brake Hydraulic Unit Ground Harness**

June 2011
FL580A
NHTSA #10V-249
Transport Canada #10-187
REVISED NOTICE

Subject: Sterling 360 Anti-Lock Brake Hydraulic Unit Ground Harness Connectors

**Models Affected: Specific Sterling 360 vehicles manufactured
August 8, 2007, through July 31, 2008.**

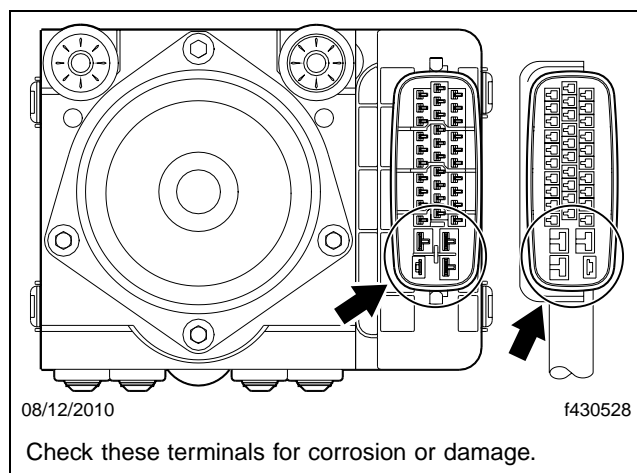
Fig. 5, Connector Terminal Inspection

8. Inspect the connector terminals on the H/U and the harness. See **Fig. 5**.

If no corrosion or other damage is found, proceed to the instructions for Sub Harness Installation, page 10.

If corrosion is present, or if the connector body is deformed or broken, request authorization to order a new ABS hydraulic unit (25-FL580-000). See the Claims for Credit section for instructions. If denied, do not replace the ABS hydraulic unit. If approved, replace the ABS hydraulic unit as follows.

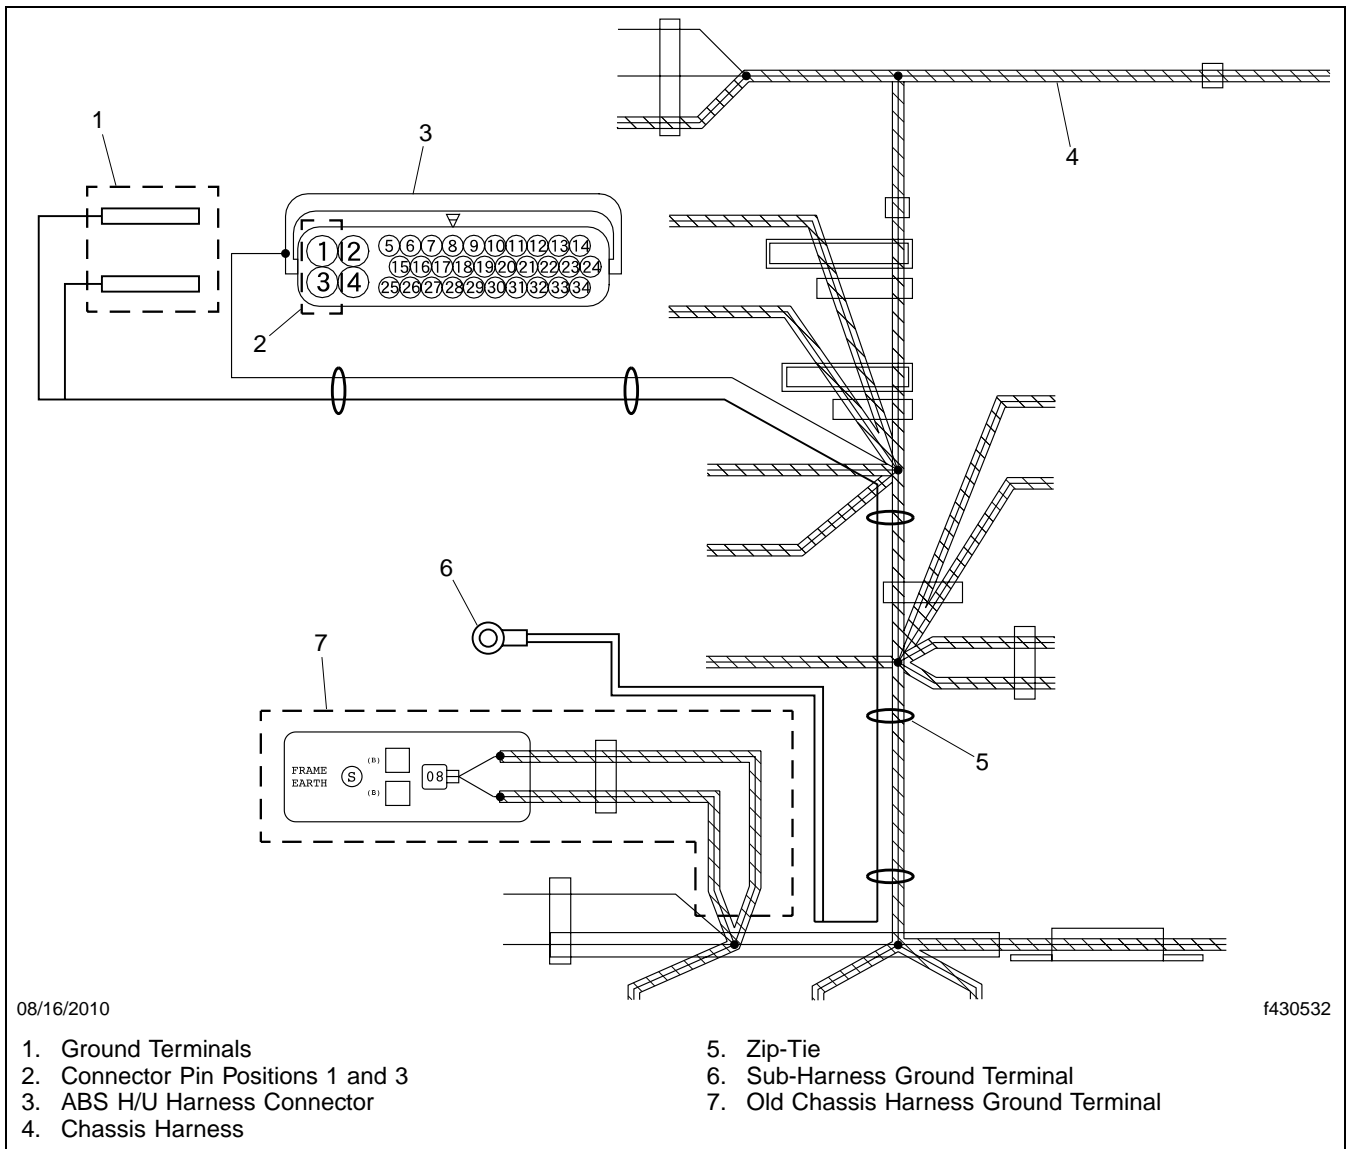
Fig. 8, Sub-Harness Installation

NOTE: The subharness replaces the ground circuit from the ABS H/U connector to the ground point on the frame rail.

1. Disconnect the two ground wires (black) from the ABS H/U connector pin positions 1 and 3. See **Fig. 8**.
2. Cut the wires off approximately 4 in (100 mm) back from the connector.
3. Rough tape the remaining wires on the ABS H/U harness.
4. Install the convoluted tubing on the ABS H/U wire loom. Secure it with tape.
5. Install the sub harness from the kit.

- 5.1 Insert the sub harness terminals into the ABS H/U connector pin positions 1 and 3.
- 5.2 Attach the subharness to the chassis harness using a zip-tie positioned approximately 7/8 in (20 mm) from the end of its convoluted tubing.
