## PRODUCT CAMPAIGN BULLETIN

**APPLICABILITY:** 2010MY Subaru Legacy & Outback  
**SUBJECT:** Steering Column Electrical  
 Roll Connector

**NUMBER:** WVR-28  
**DATE:** June 2010

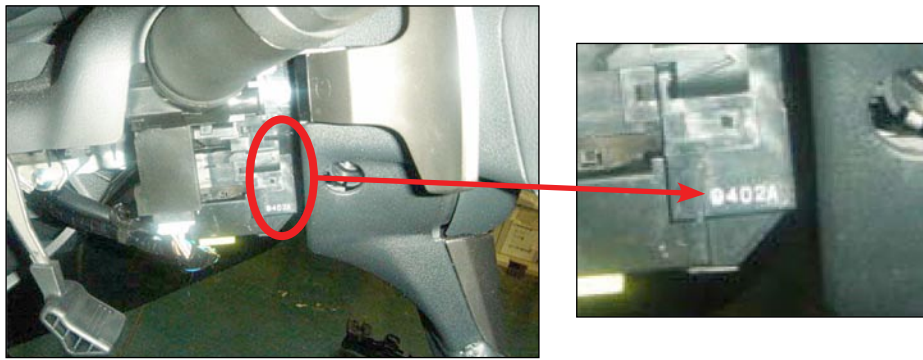
- 4) Confirm the steering roll connector lot number located on the left side of the connector.

If the lot number indicates a production date of October 14, 2009 (9X14A) or after, replacement is **not** required. Install the steering column lower cover in reverse order of removal. No further action is required.

If the lot number indicates a production date of October 13, 2009 (9X13A) or before, replacement of the steering roll connector is required. Proceed as follows.
