# Technical Bulletin

Section Title: Body, Cab and Accessories  
TSB No. TS 00 08100R

**SUBJECT:** SAFETY RECALL CAMPAIGN: SG, COUNTERMEASURE OF INSTRUMENT PANEL CENTER LOWER BOX.  
**MODEL(S):** KIZASHI (A6B424)  
**YEAR:** 2010 (BUILT BETWEEN OCTOBER 13, 2009 TO JUNE 17, 2010)

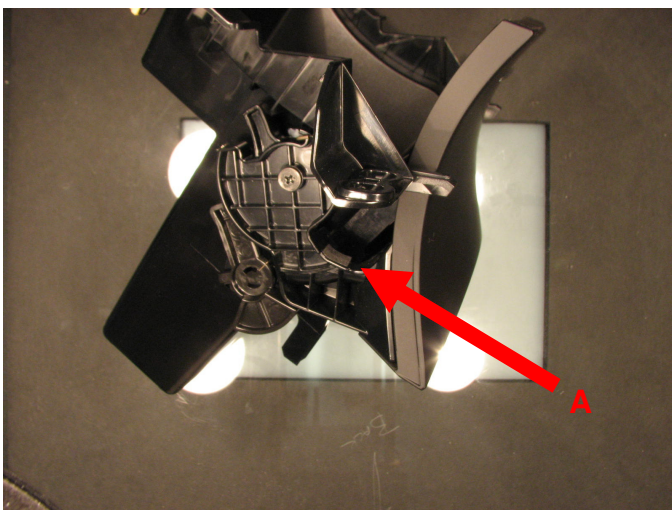
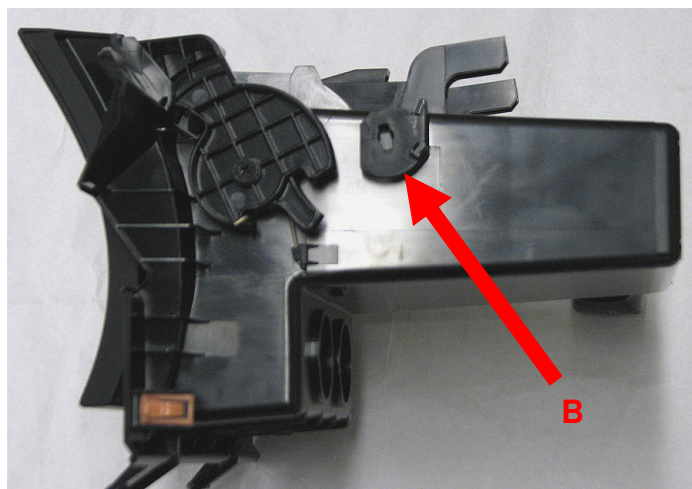
Part prior to countermeasure

**CONDITION:** The hinged door on the instrument panel center lower box may not remain closed in the event of a crash.

**CAUSE:** Improper design of the latch mechanism.

A. With counter lock lever and flat, rectangular contact pad.

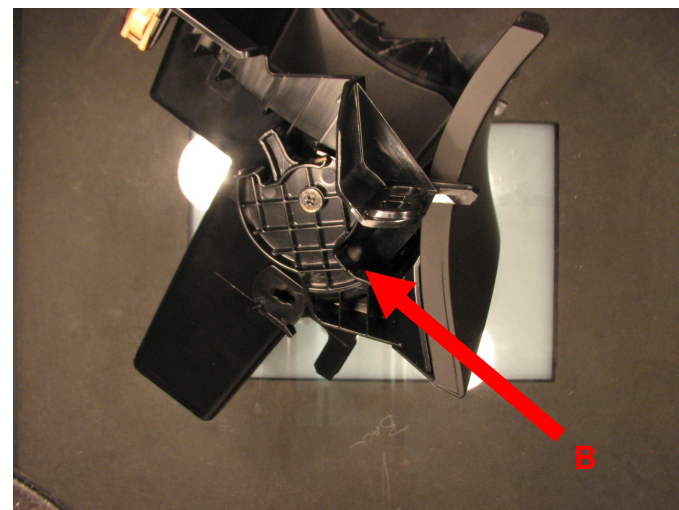
“New” countermeasure part

B. Without counter lock lever and cone shaped contact pad.

**CORRECTION:** Please replace the instrument panel center lower box with a new replacement part. This will be performed at no charge to the customer for parts or labor.
