Technical Service Bulletin									
Date Issued	Model Year(s) Affected			Model(s) Affected		TSB #			
12/17/2010	2008-2010			Dutch Star, Dutch Aire, Mountain Aire		378			
Brand						Type			
All <input type="checkbox"/>	American Star <input type="checkbox"/>	Mountain Aire <input type="checkbox"/>	All <input type="checkbox"/>	TT <input type="checkbox"/>					
Cypress <input type="checkbox"/>	Dutch Star <input checked="" type="checkbox"/>	Kountry Aire <input type="checkbox"/>	FW <input type="checkbox"/>	CA <input type="checkbox"/>					
Northern Star <input type="checkbox"/>	Kountry Star <input type="checkbox"/>	Essex <input type="checkbox"/>	DP <input checked="" type="checkbox"/>	DB <input type="checkbox"/>					
Scottsdale <input type="checkbox"/>	King Aire <input type="checkbox"/>	Dutch Aire <input checked="" type="checkbox"/>							
All Star ME <input type="checkbox"/>	Ventana <input type="checkbox"/>	Bay Star <input type="checkbox"/>							
<table style="width:100%; border: none;"> <tr> <td style="width: 50%; vertical-align: top;"> <input type="checkbox"/> Air Conditioning & Heating <input type="checkbox"/> Appliances & Accessories <input type="checkbox"/> Cabinets & Furniture <input

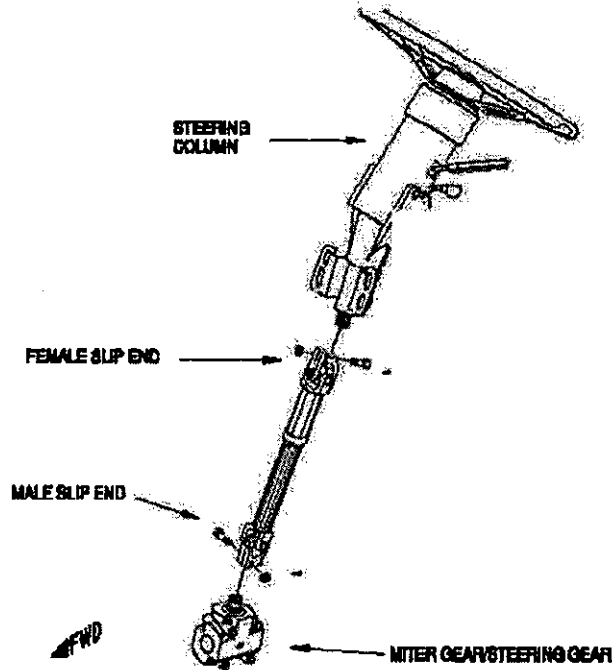
FIG. 3-1

TYPICAL INTERMEDIATE SHAFT SHOWN

4. Center steering wheel prior to removing the steering slip shaft.
5. Remove clamp at the top of the steering column rubber boot located at the bottom of the steering column going to the floor to gain access to the pinch bolt located at the top of slip shaft. Retain clamp for reuse.
6. Refer to FIG. 3-1. Remove pinch bolt at steering column end of steering slip shaft. Properly discard hardware.
7. Refer to FIG. 3-1. Remove steering slip shaft from bottom of steering column.

8. Refer to FIG. 3-1. Remove pinch bolt at gear box and or miter box end of steering slip shaft. Properly discard hardware.
9. Refer to FIG. 3-1. Remove steering slip shaft and retain to ship back to Spartan Motors Chassis, Inc.

10. Refer to FIG. 3-1. Install new slip shaft in reverse order using new hardware. Torque bolts to proper values listed in service kit information on pages 1 and 2.
11. Reinstall rubber boot and clamp. Secure as needed.
12. If any power source was disconnected reconnect power source.
