Voluntary Safety Recall – A0H  
Certain 2000 through 2004 Toyota Avalon Vehicles  
Steering Column Upper Bracket Replacement  
\*\*\*\*\*URGENT\*\*\*\*\*

Volume: XVI  
Number: TC10-045  
Date: 08/31/2010  
 Action  
 Retain  
 Information

Subject: Voluntary Safety Recall – AOH  
Certain 2000 through 2004 Toyota Avalon  
Steering Column Upper Bracket Replacement

Subject: Voluntary Safety Recall – A0H  
Certain 2000 through 2004 Toyota Avalon  
Steering Column Upper Bracket Replacement

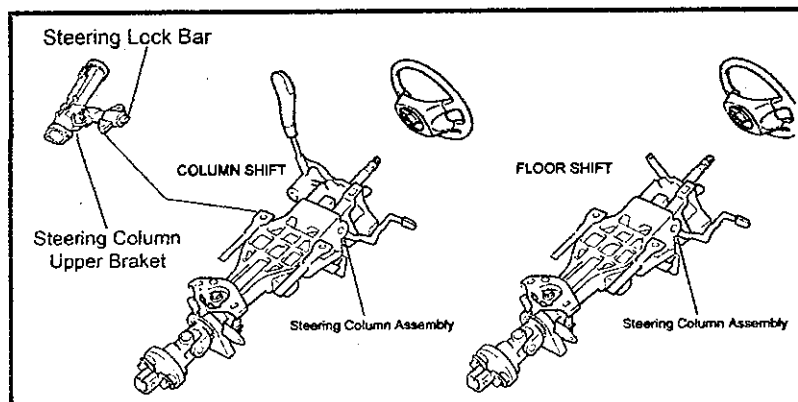
Due to the improper casting of the steering lock bar ("bar"), which is a component of the steering interlock system, there is a possibility that a minute crack may develop on the surface. Such a crack may expand over a long period of repeated lock and unlock operations, and eventually the bar could break. If this occurs, the interlock system may become difficult to unlock when stationary.

If the vehicle while being driven is steered to the right with sufficient lateral acceleration, a broken and loose lock bar may move toward the steering shaft. If the engagement hole in the shaft happens to line up at the specific time the broken lock bar has moved, this could cause the steering wheel lock bar to engage, locking the steering wheel, and increasing the risk of a crash.

Toyota dealers are requested to replace the Steering Column Upper Bracket at **NO CHARGE** to the vehicle owner.

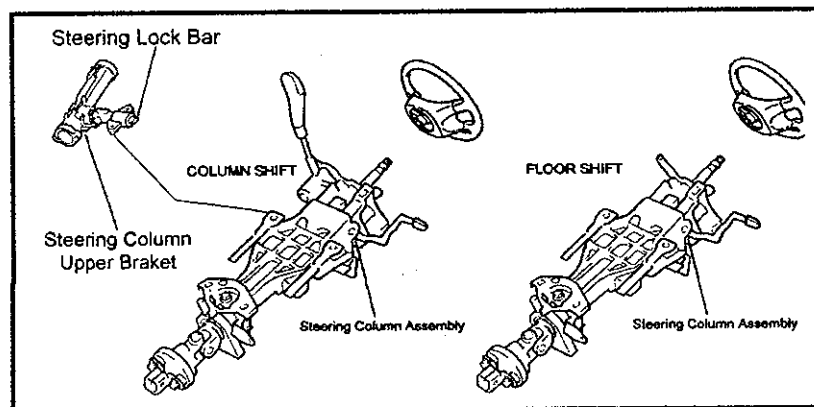
Due to the improper casting of the steering lock bar ("bar"), which is a component of the steering interlock system, there is a possibility that a minute crack may develop on the surface. Such a crack may expand over a long period of repeated lock and unlock operations, and eventually the bar could break. If this occurs, the interlock system may become difficult to unlock when stationary.

If the vehicle while being driven is steered to the right with sufficient lateral acceleration, a broken and loose lock bar may move toward the steering shaft. If the engagement hole in the shaft happens to line up at the specific time the broken lock bar has moved, this could cause the steering wheel lock bar to engage, locking the steering wheel, and increasing the risk of a crash.

Toyota dealers are requested to replace the Steering Column Upper Bracket at **NO CHARGE** to the vehicle owner.
