CABLE TIE
 Models: Multistrada 1200 (all versions)
 Recall Bulletin RCL-10-001

Date: Monday, July 26, 2010
 To: Dealer Principal, Service Manager, North American Dealer Network
 From: Austin Gray, Technical Director; Jonathan LaForte, Technical Manager

NHTSA Campaign I.D. Number: 10V-###
 Transport Canada Safety Recall I.D. Number: 10-###

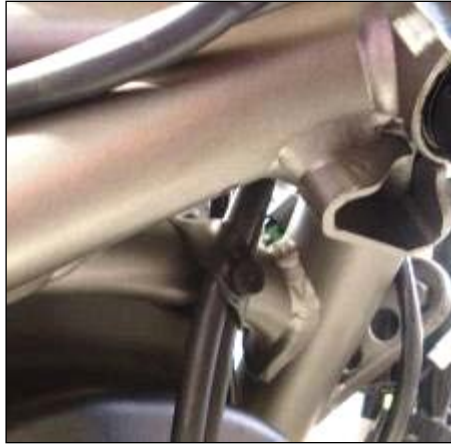
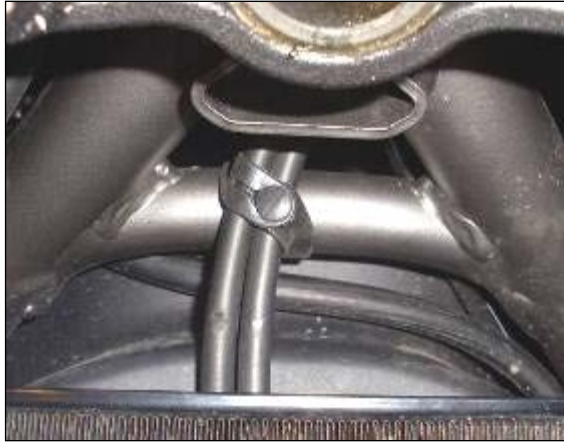
- The throttles cables can come in contact with the upper edge of the radiator, resulting in damage to cables due to chafing.

- Apply an L=82 tie (part no. 741.1.013.1A) between the throttle cables and the frame.

4. Lower the water radiator to allow access to the frame;
5. Fit a tie with part number 741.1.013.1A between the frame and the throttle cables as shown in the following pictures;
