September 2011  
FL583A  
NHTSA #10V-360  
Transport Canada #10-258

## Subject: Business Class M2 Headlight Height

**Models Affected:** Specific Freightliner Business Class M2 vehicles manufactured April 12, 2010, through July 16, 2010.

# Recall Campaign

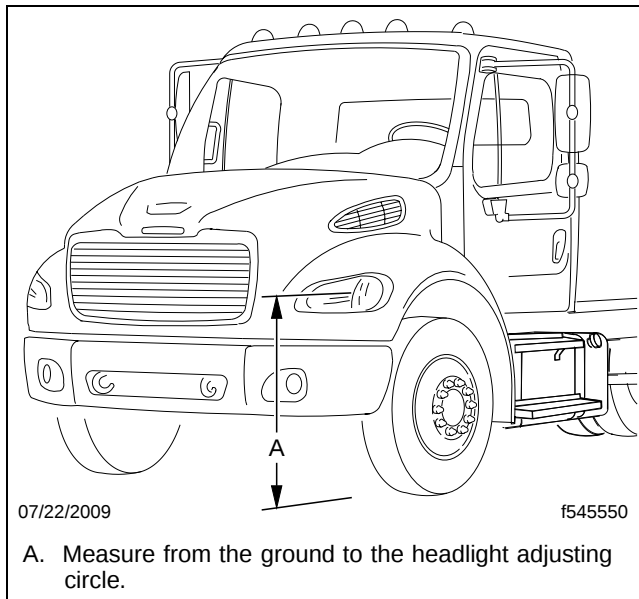
**Fig. 1, Headlight Measurement**

- 3.2 Measure from the ground to the center of the highest headlight lens. See **Fig. 1** and **Fig. 2**. If this height is 54 inches (137 cm) or less, nothing more needs to be done. Clean a spot on the base label (Form WAR259) and attach a completion sticker for FL583 (Form WAR260) to the base label.

If the height is more than 54 inches (137 cm), go to the next step.

16. Install the mounting capscrews.
17. Install the headlight cover.
18. Close the hood.
19. Connect the batteries.
20. Check the height of the headlights. Measure from the ground to the center of the highest headlight lens. See **Fig. 1** and **Fig. 2**. The height should be 54 inches (137 cm) or less.
