**REGIONAL SAFETY RECALLS 13V-547, 12V-306 AND 10V-436
BULLETIN UPDATE ANNOUNCEMENT**

This letter and specific bulletin sections are being sent to you to notify you of bulletin updates for Safety Recalls 13V-547, 12V-306 and 10V-436 – Corrosion Affecting the Forward Mounting Point for Rear Suspension Lower Link Brackets on certain Isuzu passenger vehicles.

PROCEDURE INFORMATION UPDATE – ALL BULLETINS

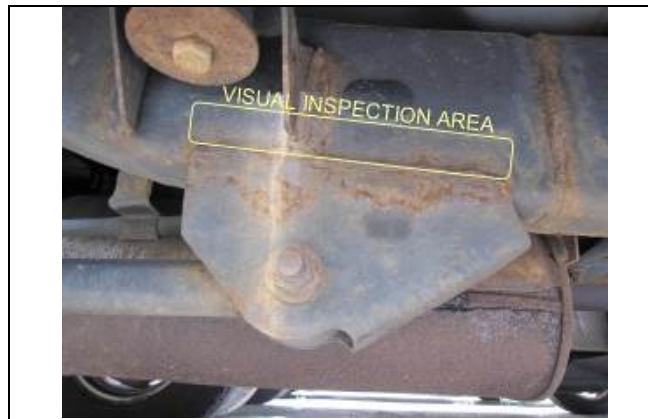
Figure 1 – Visual Inspection Area

2. Using a 3/16" flat punch and a 12-16 oz. hammer, hammer on the locations identified with an "X" in Figure 2. Swing the hammer 10 to 12 inches to be sure enough force is applied to the punch. If a hole is created go to Step 4. If no hole is created, visually inspect the Rear Lower Trailing Link Front Mounting Bracket inspection area. Use the Visual Comparison Photo (P/N 2-90SVA-003-0) or Figure 1 for reference. If most of the frame coating is still in place and very little surface rust is present, apply Noxudol 300 (Go to "Condition One: Apply Noxudol 300" in this bulletin). If most frame coating is missing and excessive rust is present go to the next step.

3. Apply Noxudol 700 and Noxudol 300 (Go to "Condition Two: Apply Noxudol 700 and Noxudol 300" in the appropriate bulletin).
4. Using a 3/16" flat punch and a 12-16 oz. hammer, hammer on the locations identified with an "X" in Figure 3.
 - a. If no hole is created, continue to Condition Three in the appropriate bulletin.
 - b. If the flat punch creates a hole in any one location, continue to Condition Four in the appropriate bulletin.
