Product Recall

Subject: RECALL 10V-486/10V-487 National Driver's Seat Pedestal

Technical Service Bulletin
NSC22955401
Seat Shock Replacement

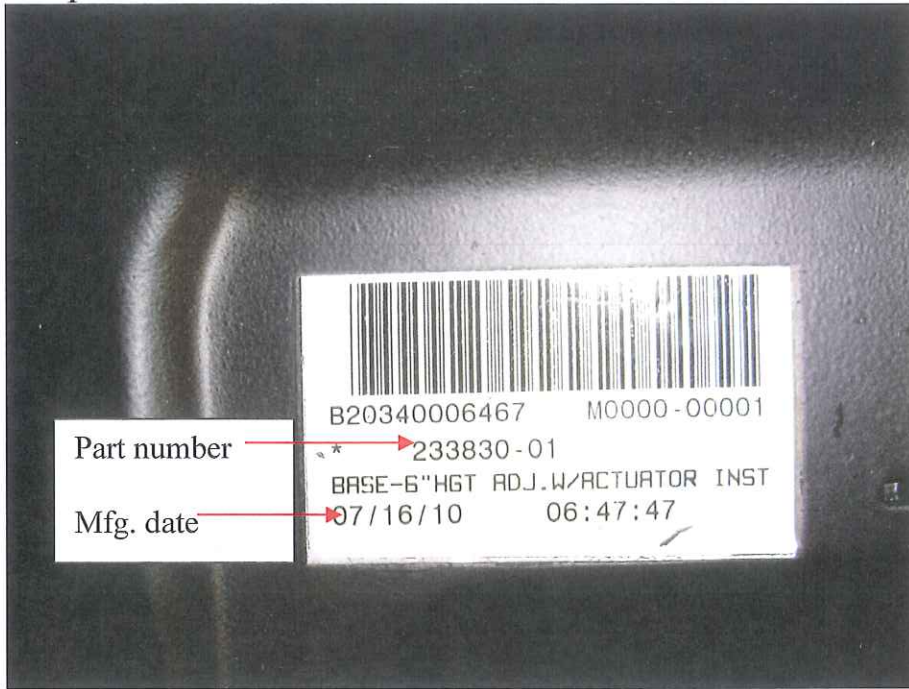
Seat Base part number: The seat base has a bar code tag on top of it that contains the part number and the date of manufacture. See example below.

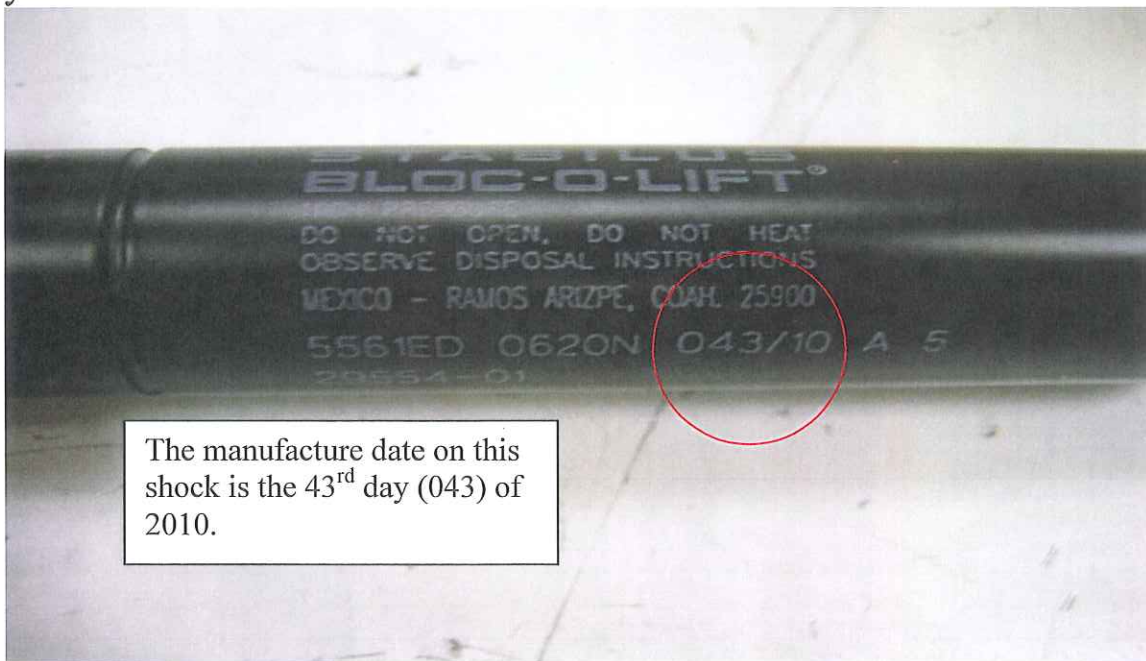
Shock part number: The part number and manufacture date is on the side of the shock. The date is a five digit code that identifies the day of manufacture and the year.

The manufacture date on this shock is the 43rd day (043) of 2010.
