## Product Recall

Subject: RECALL 10V-486/10V-487 National Driver's Seat Pedestal

Technical Service Bulletin  
NSC22955401  
Seat Shock Replacement

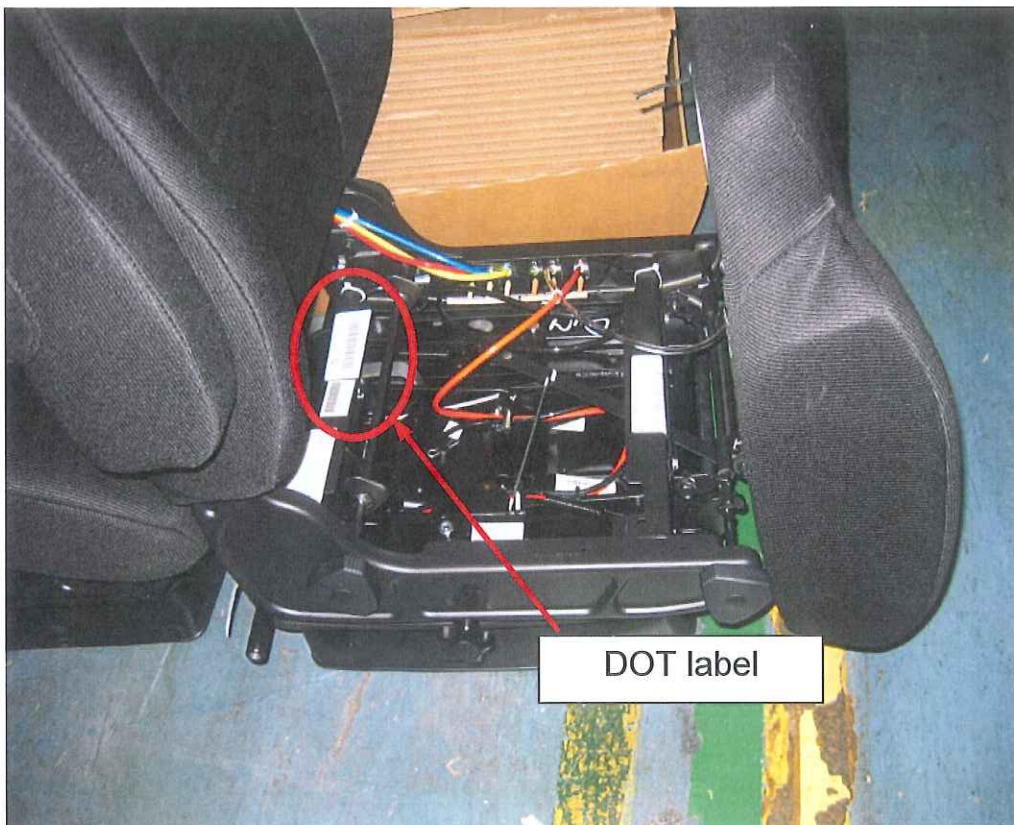
Seat part number: Flip the seat cushion forward to expose the DOT label

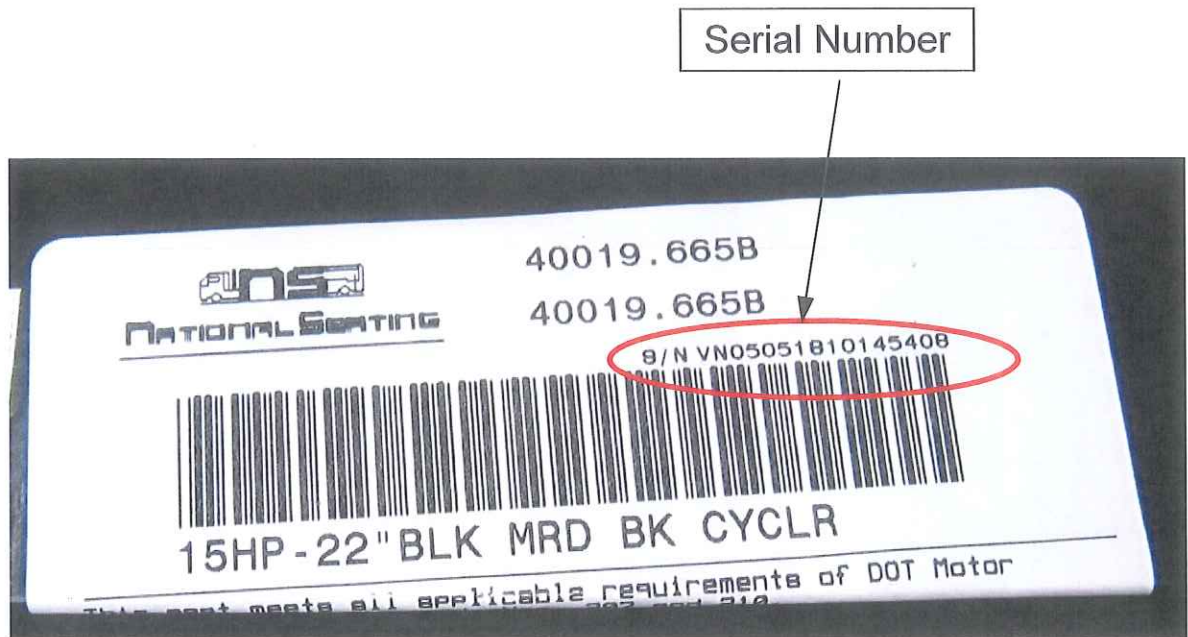
## DOT Label

The serial number on the DOT label Identifies the date of manufacture of the seat.

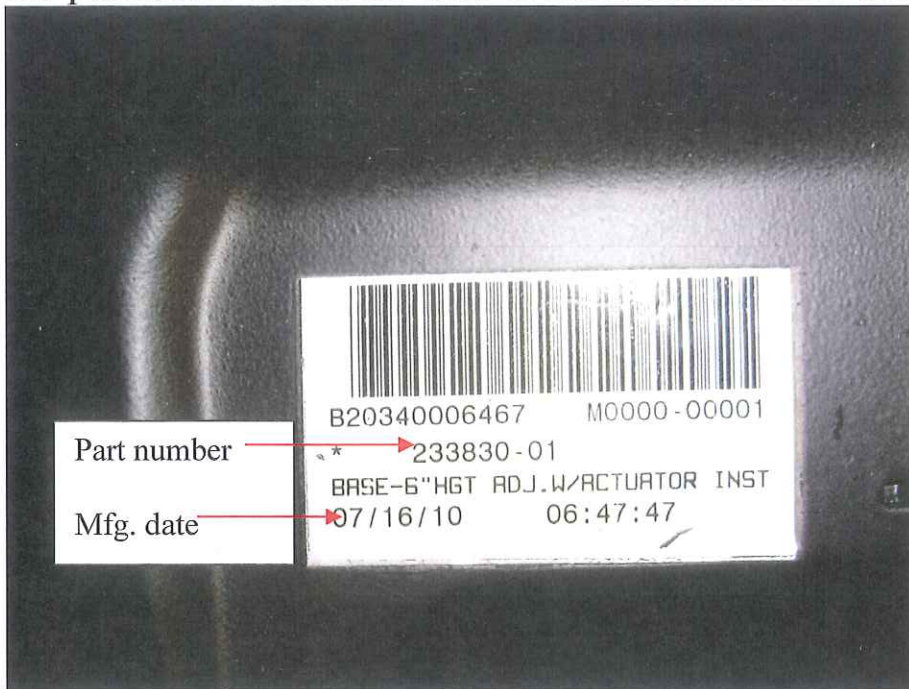
Seat Base part number: The seat base has a bar code tag on top of it that contains the part number and the date of manufacture. See example below.

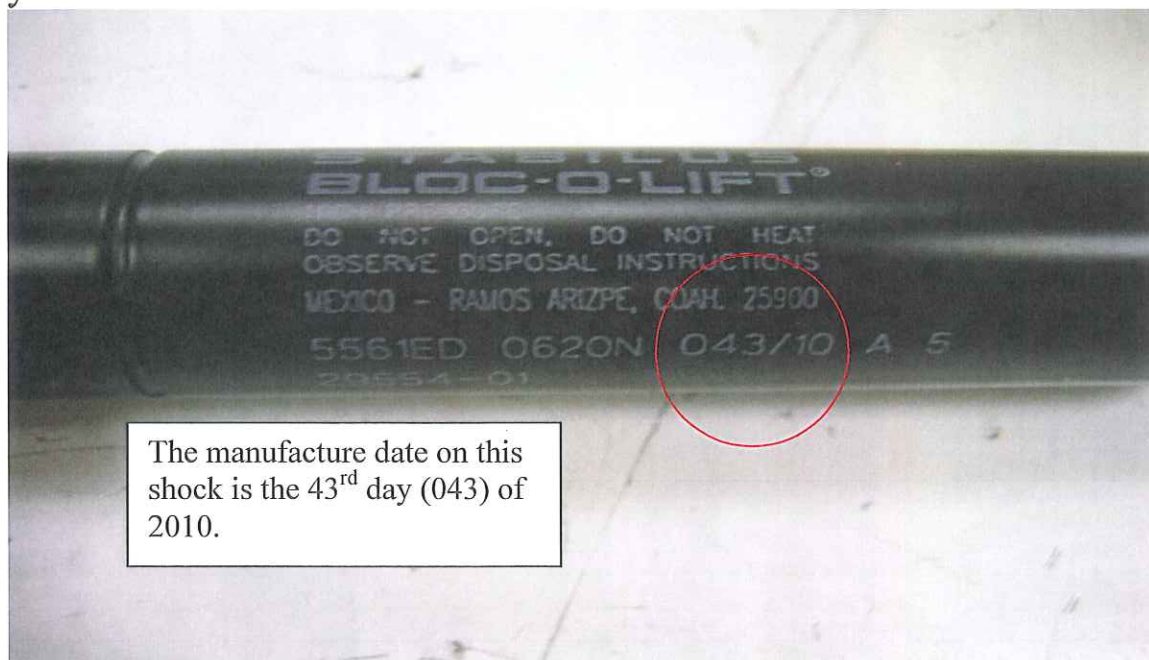
Shock part number: The part number and manufacture date is on the side of the shock. The date is a five digit code that identifies the day of manufacture and the year.

The manufacture date on this shock is the 43<sup>rd</sup> day (043) of 2010.

If you identify you have a shock within the defined date range National Seating will provide one of the following remedies;
