Subject: Safety Recall ALG - Remedy Available
Certain 2004 - 2006 RX 330, 2006 GS 300, 2006 IS 250 and 2006 IS 350 Vehicles
Rubber Seal (Brake Master Cylinder Cup)

TECHNICAL INSTRUCTIONS
FOR
SAFETY RECALL ALG
RUBBER SEAL (BRAKE MASTER CYLINDER CUP) REPLACEMENT
2006 MODEL YEAR GS 300
2006 MODEL YEAR IS 250 & IS 350
2004 – 2006 MODEL YEAR RX 330

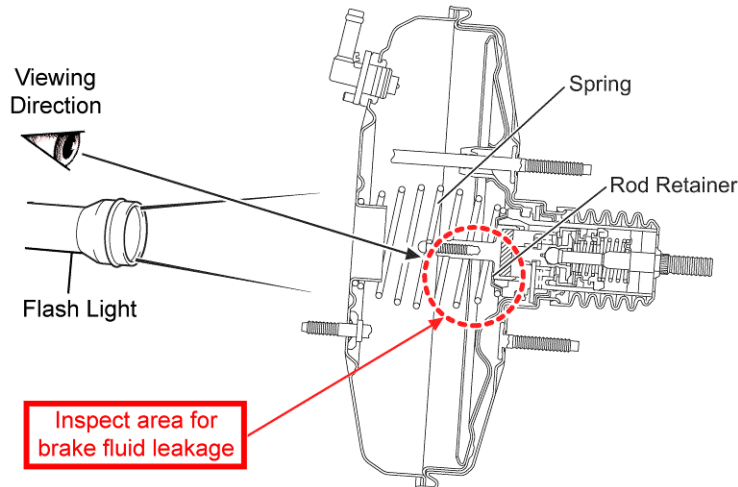
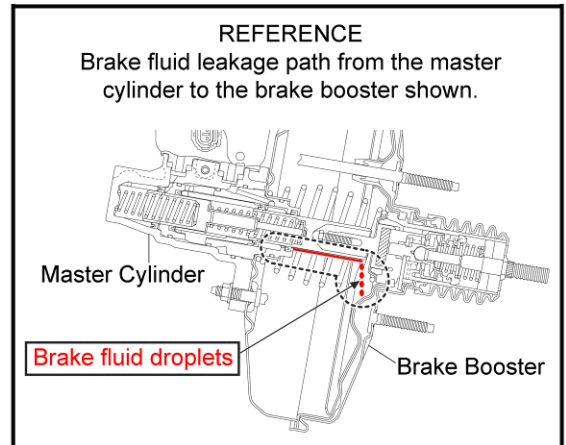
- As shown below, visually inspect the booster for signs of brake fluid leakage from the master cylinder.

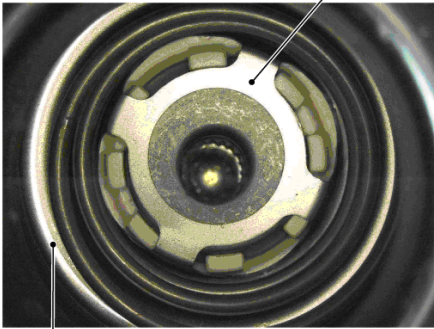
Brake Booster Judgment Criteria	Result & Action
<p>No fluid found.</p>

<p>Rod Retainer</p> <p>Spring</p>	<p>Booster is OK</p> <p>Replace the cylinder cup as outlined in section F.</p>
<p>Fluid droplet(s) are visible on the rod retainer and/or spring.</p>

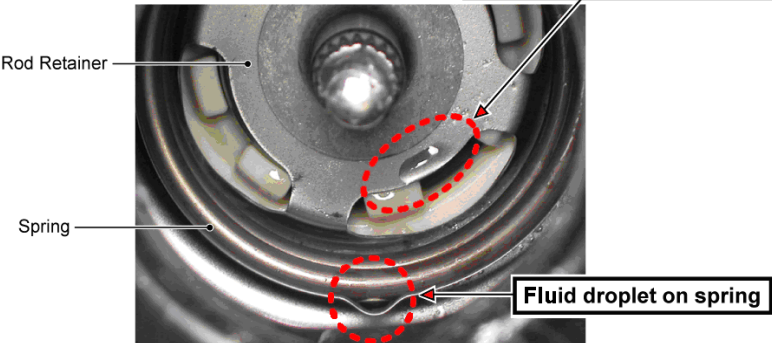
<p>Rod Retainer</p> <p>Spring</p> <p>Fluid droplet on rod retainer</p> <p>Fluid droplet on spring</p>	<p>Booster requires additional inspection</p> <p>Proceed to section D "SECONDARY INSPECTION FOR BRAKE FLUID LEAKAGE"</p>

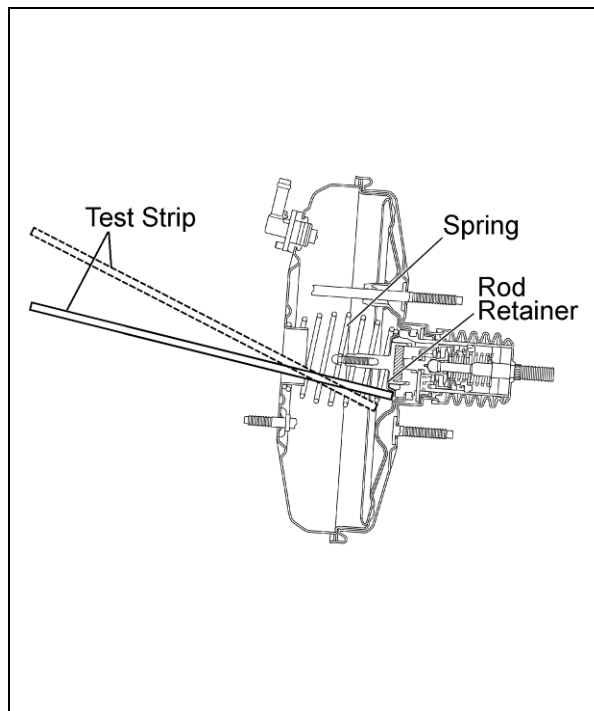
2. BRAKE FLUID LEAK CHECK PART 1

- Insert a new test strip in the locations shown or where the fluid was found.
- Remove the test strip and let it sit for 1 minute, then determine the judgement using the table below.

Judgement	Result
	Assembly oil detected. Booster requires additional inspection Proceed to step 3 "BRAKE FLUID LEAK CHECK PART 2".
	Brake fluid detected. Booster is NG Replace the brake booster as outlined in section E. & Replace the cylinder cup as outlined in section F.

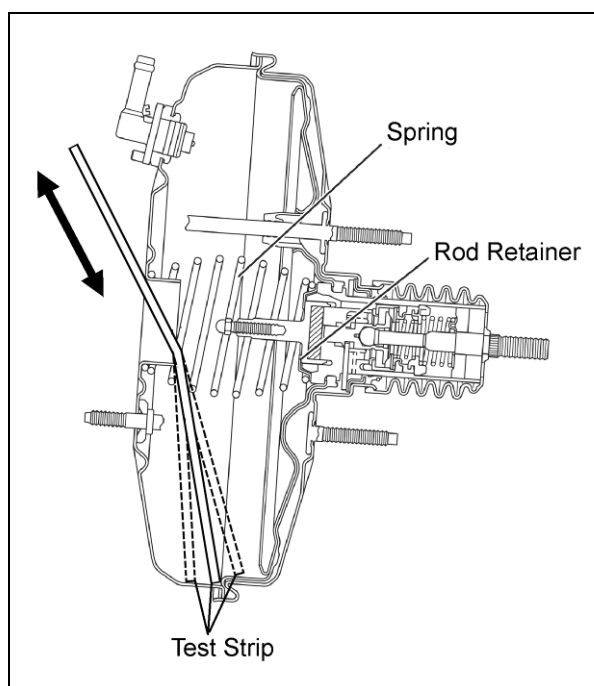
3. BRAKE FLUID LEAK CHECK PART 2

- Insert a new test strip inside the bottom of the booster in the locations shown.
- Remove the test strip and let it sit for 1 minute, then determine the judgement using the table below.

Judgement	Result
	Assembly oil detected. Booster is OK Replace the cylinder cup as outlined in section F.
	Brake fluid detected. Booster is NG Replace the brake booster as outlined in section E. & Replace the cylinder cup as outlined in section F.
