Subject: Safety Recall A0M – Rubber Seal (Brake Master Cylinder Cup)
Certain 2005 through 2006 Model Year Toyota Avalon Vehicles &
Certain 2004 through 2006 Model Year Highlander (Non Hybrid) Vehicles

TECHNICAL INSTRUCTIONS
FOR
SAFETY RECALL A0M
RUBBER SEAL (BRAKE MASTER CYLINDER CUP) REPLACEMENT
2004 – 2006 MODEL YEAR HIGHLANDER
2005 – 2006 MODEL YEAR AVALON

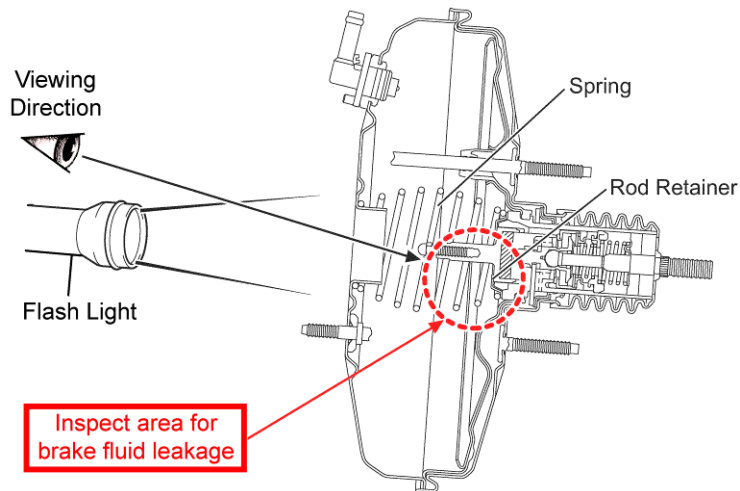
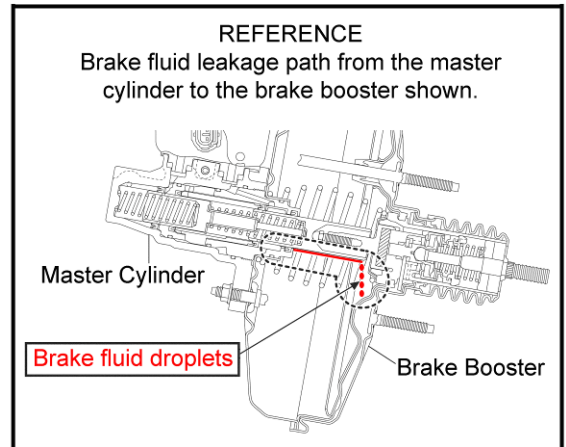
2. VISUAL INSPECTION FOR BRAKE FLUID LEAKAGE

- As shown below, visually inspect the booster for signs of brake fluid leakage from the master cylinder.

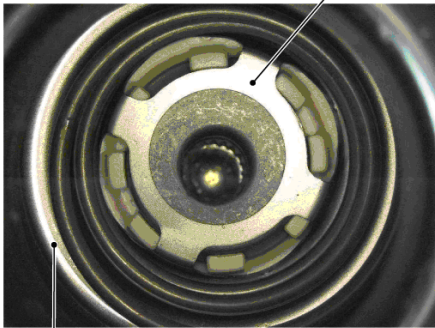
Brake Booster Judgment Criteria	Result
<p>No fluid found.</p>

<p>Rod Retainer</p> <p>Spring</p>	<p>Booster is OK</p> <p>Replace the cylinder cup as outlined in section F.</p>
<p>Fluid droplet(s) are visible on the rod retainer and/or spring.</p>

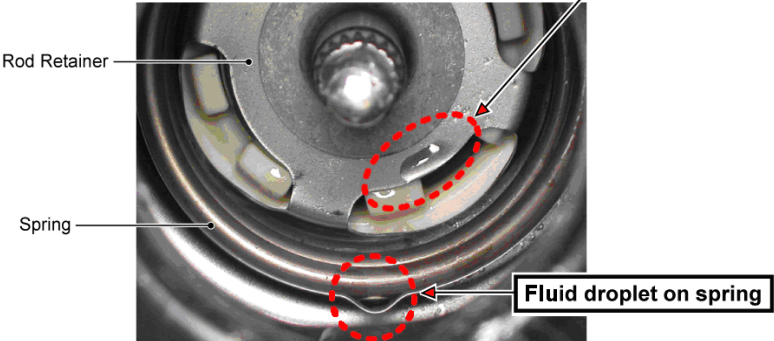
<p>Rod Retainer</p> <p>Spring</p> <p>Fluid droplet on rod retainer</p> <p>Fluid droplet on spring</p>	<p>Booster requires additional inspection</p> <p>Proceed to section D "SECONDARY INSPECTION FOR BRAKE FLUID LEAKAGE"</p>

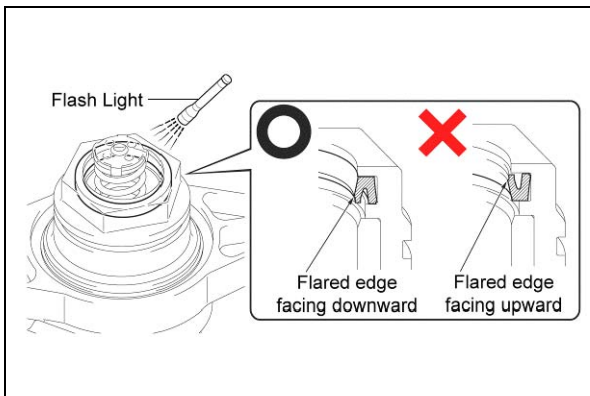
- Confirm the positioning of the **NEW** Rubber Seal (Brake Master Cylinder Cup), making sure the flared edge is facing down.

- Confirmation of the Rubber Seal (Brake Master Cylinder Cup) position may be difficult. To help, shine a light in the direction shown during the inspection.
- If the Rubber Seal (Brake Master Cylinder Cup) is installed incorrectly (flared edge facing up) it **MUST** be replaced with a new one.
