December 13, 2010  
TMS-NTC-10259

Subject: Safety Recall AOP – **Preliminary Notice**  
Certain 2011 Model Year Sienna Vehicles  
Brake Light (Stop Lamp) Switch Bracket

## (A1P) – SAFETY RECALL 2011 MODEL YEAR SIENNA BRAKE LIGHT (STOP LAMP) SWITCH BRACKET DEALER STOCK VEHICLE INSPECTION GUIDE

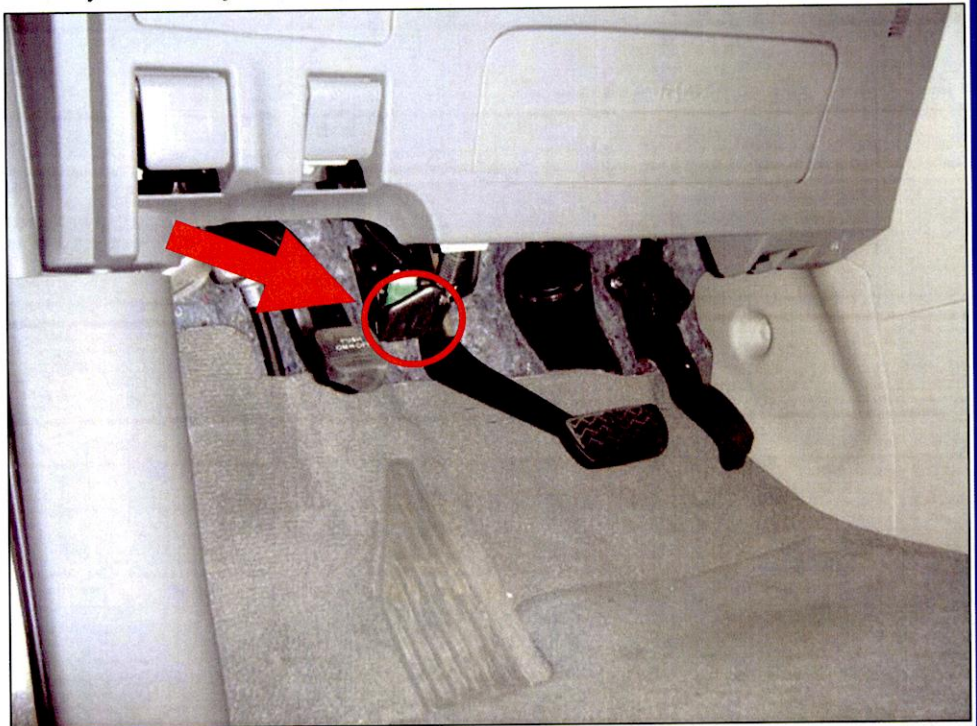
2. Locate and inspect the Brake Light (Stop Lamp) Switch Bracket.

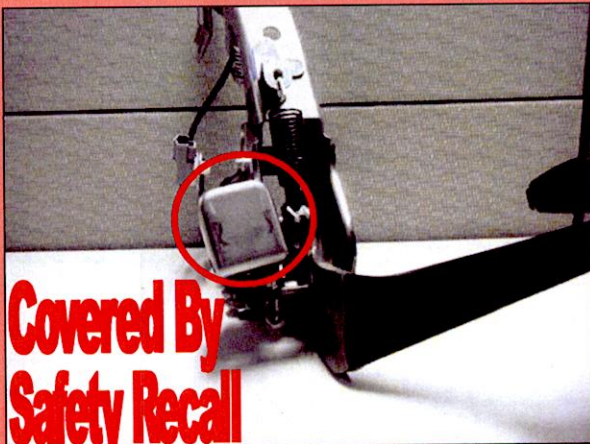
3. Visually inspect the stop light switch bracket **shape**.

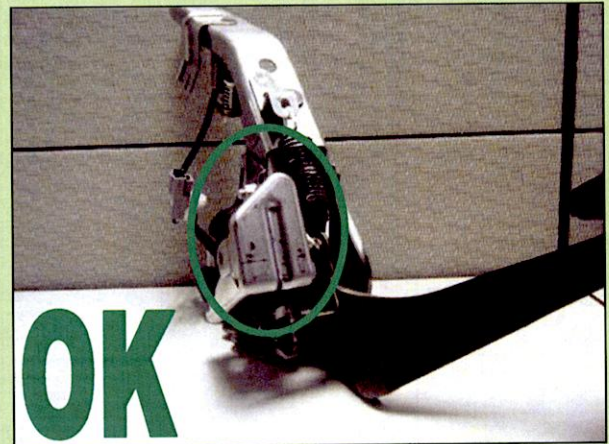
**Covered By  
Safety Recall**

- In the subject vehicles, the stop lamp switch is mounted on a small bracket welded on the left side of the brake pedal support assembly. The bracket is relatively close to the parking brake pedal when the parking brake is fully applied. Due to its proximity to the parking brake pedal, in limited circumstances the stop lamp switch bracket could be deformed (bent) by the driver's foot during parking brake application. Depending on the amount of bracket deformation, this condition could result in the stop lamp switch engaging and causing the brake lights to remain on. If the deformation is significant, the service brake could become partially engaged due to contact from the bracket, resulting in brake drag with associated brake noise, vibration, and/or illumination of the brake warning light. If the driver does not notice these conditions and continues to drive the vehicle, braking effectiveness could be reduced.

If the stop light switch bracket is this shape hold the vehicle. Repair instructions will be provided shortly.

- Toyota will replace the bracket assembly which includes the stop lamp switch bracket with one of a different shape. Toyota is currently preparing the remedy parts. We anticipate that preparations will be completed in late February, 2011.
