Subject: Safety Recall A0P – **Remedy Notification**
Certain 2011 Model Year Sienna Vehicles Brake Light (Stop Lamp) Switch Bracket

TECHNICAL INSTRUCTIONS

SAFETY RECALL A0P

BRAKE LIGHT (STOP LAMP) SWITCH BRACKET REPLACEMENT

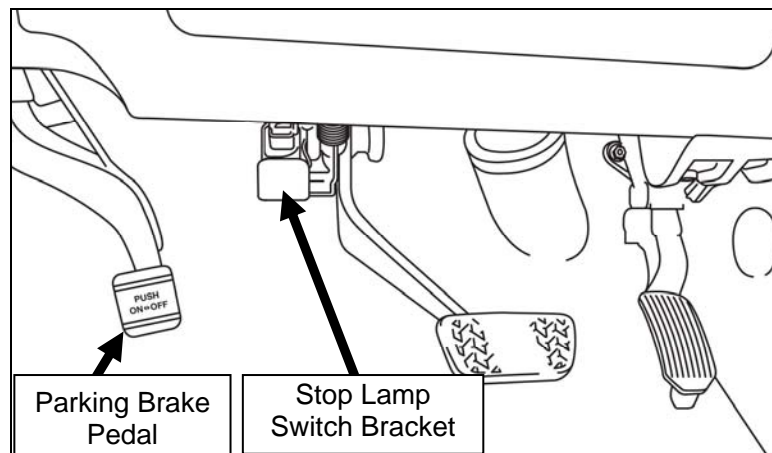
Prior to your appointment, please be aware of the close proximity of the stop lamp switch bracket to the parking brake pedal, shown in the diagram below. You may minimize the possibility of this condition occurring until the remedy is performed by assuring the bracket is not bent. We apologize for any inconvenience created by this condition.

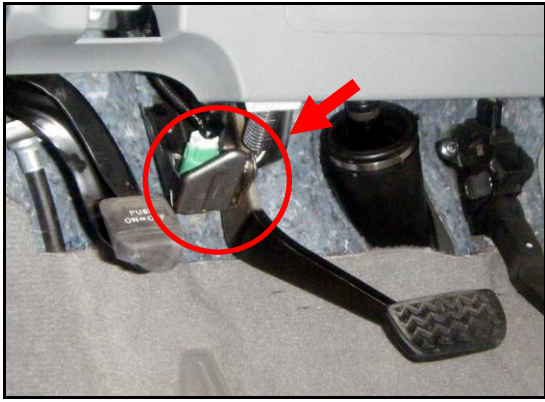
A. LOCATE AND INSPECT THE BRACKET ASSEMBLY

1. VISUALLY INSPECT THE BRAKE LIGHT (STOP LAMP) SWITCH MOUNTING BRACKET SHAPE

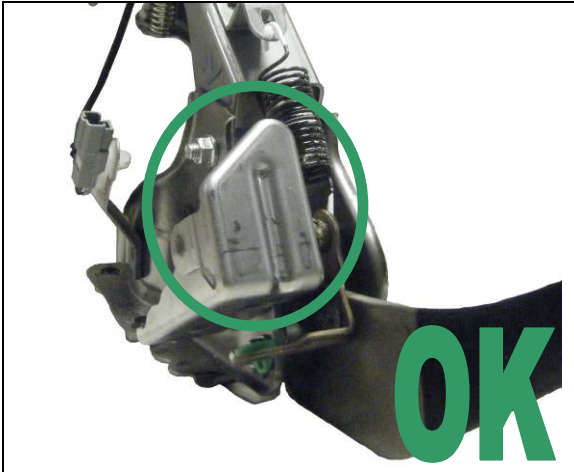
OK: NOT covered by Safety Recall

- a) If the bracket shape is as shown the vehicle ***IS NOT*** affected. The campaign is completed.

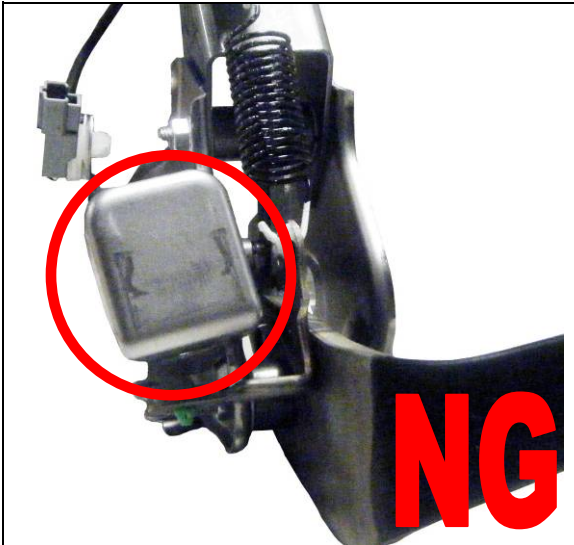
NG: Covered by Safety Recall

- b) If the bracket shape is as shown continue to ***STEP B*** (Replace the bracket assembly).
