**Sprinter Engineering and  
Compliance Support**

Campaign No. 2011010001, March 2011

SUBJECT: **Model 906, Model Year 2010**  
**Replace A-Pillar Trim**

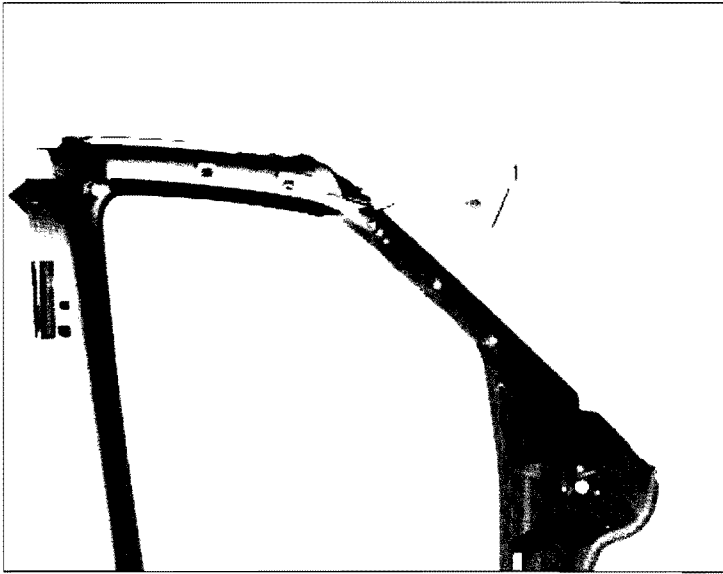
**Figure 1**

Daimler AG (DAG), the manufacturer of Mercedes-Benz and Freightliner Sprinter vehicles, has determined that due to documentation error the A-Pillar Trim installed in the vehicle may not be the correct one required for compliance with Federal Motor Vehicle Safety Standard (FMVSS) 201 (Head Impact Protection). Dealers will replace the A-Pillar Trim to insure compliance with FMVSS 201.

1. Remove A-pillar trim (1, Figure 1) from A-pillar.
2. Install new A-pillar trim (1, Figure 1) in reverse order.
