BLUE BIRD

**SUBJECT: RECALL R11SU FMVSS 221 JOINT STRENGTH NONCOMPLIANCE-
ADHESIVE OMITTED AT 20 GAUGE OUTSIDE SIDE
PANEL JOINTS**

FMVSS 221 Joint Strength Noncompliance Adhesive Omitted on 20 Gauge Outside Side Panels

**Models Affected: 2010 Model Year All American (D3) Model School Buses
with Optional 20 Gauge Outside Side Panels**

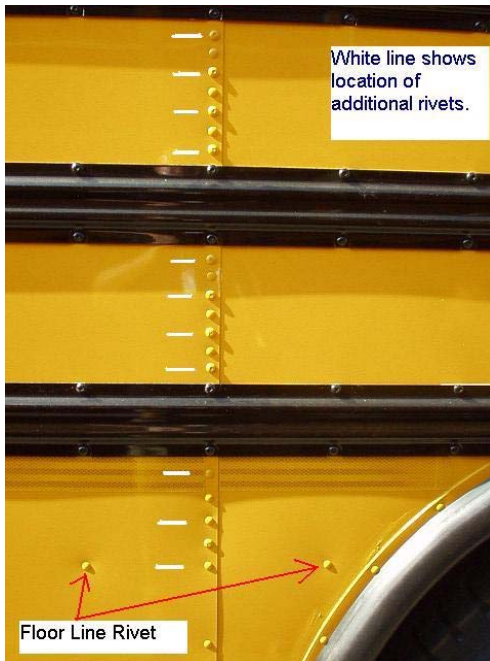
Adhesive required to meet FMVSS 221 Joint Strength requirements may have been omitted at 20 gauge outside side panel joints.

Photo 1
Spacing from bottom edge of window line rub rail to floor line.

- Using a 17/64" drill bit, drill additional rivet holes at each outside side panel joint as indicated by white dash line in Photo #1 below. A drill stop set at 1/2" (0.50) must be used to prevent possible damage to wires in bow cavities. Be sure holes are evenly spaced between existing rivets and that holes stay in line with existing rivets.

- Install part number #01854397 Rivet, Blind, .25 Dia, .38 grip, in each hole drilled using a rivet gun/tool.
- On the street side of the bus, remove the stop arm to allow installation of the additional rivets in beltline area, then reinstall stop arm.

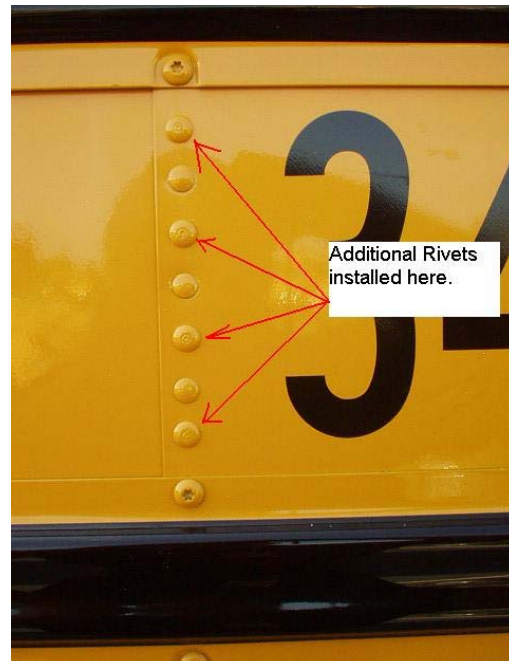
Photo 2
Close up of spacing between rubrails
