CAMPAIGN BULLETIN	02-591-10
--------------------------	------------------

Models Affected: XT60 Aerials

SUBJECT: *Weld inspection XT60 Lower Boom*

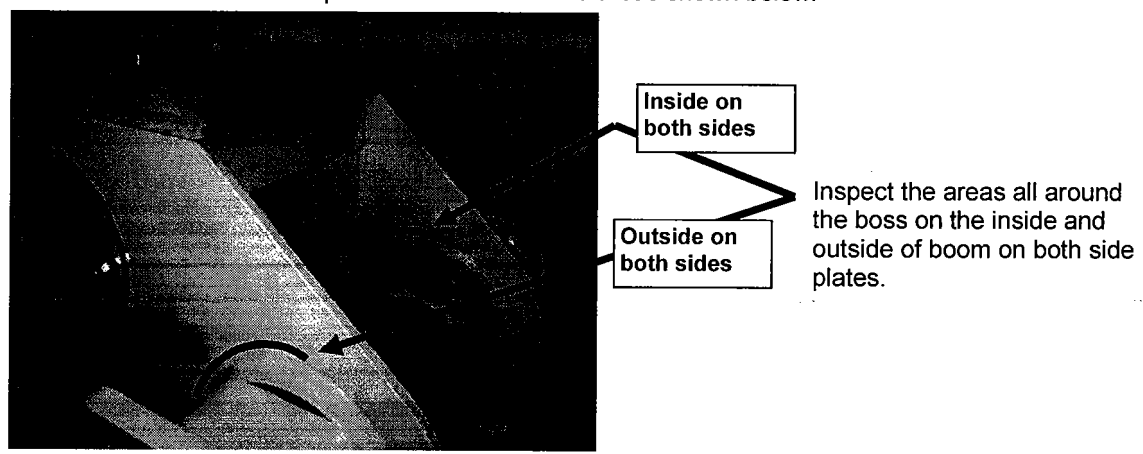
TEREX Utilities has received reports of cracks in the welds that have progressed into failure of the side plate at the lower boom hinge pin on XT60 aerials. The failure originates at the joint between the boom tube and pivot boss in the side plates. **The failure of the plates will cause unexpected motion of the boom and possible falling of the platform.**

Immediately inspect for cracks in or near the welds of the lower boom side plates shown below before further use of the machine.

1. Clean the area around the boss.
2. Perform a visual inspection for cracks in the areas shown below.

- **If any cracks are detected do not continue to operate the unit, take it out of service immediately.** Send in the completed form and contact TEREX Utilities at 605-884-3892 to arrange repairs before further use.

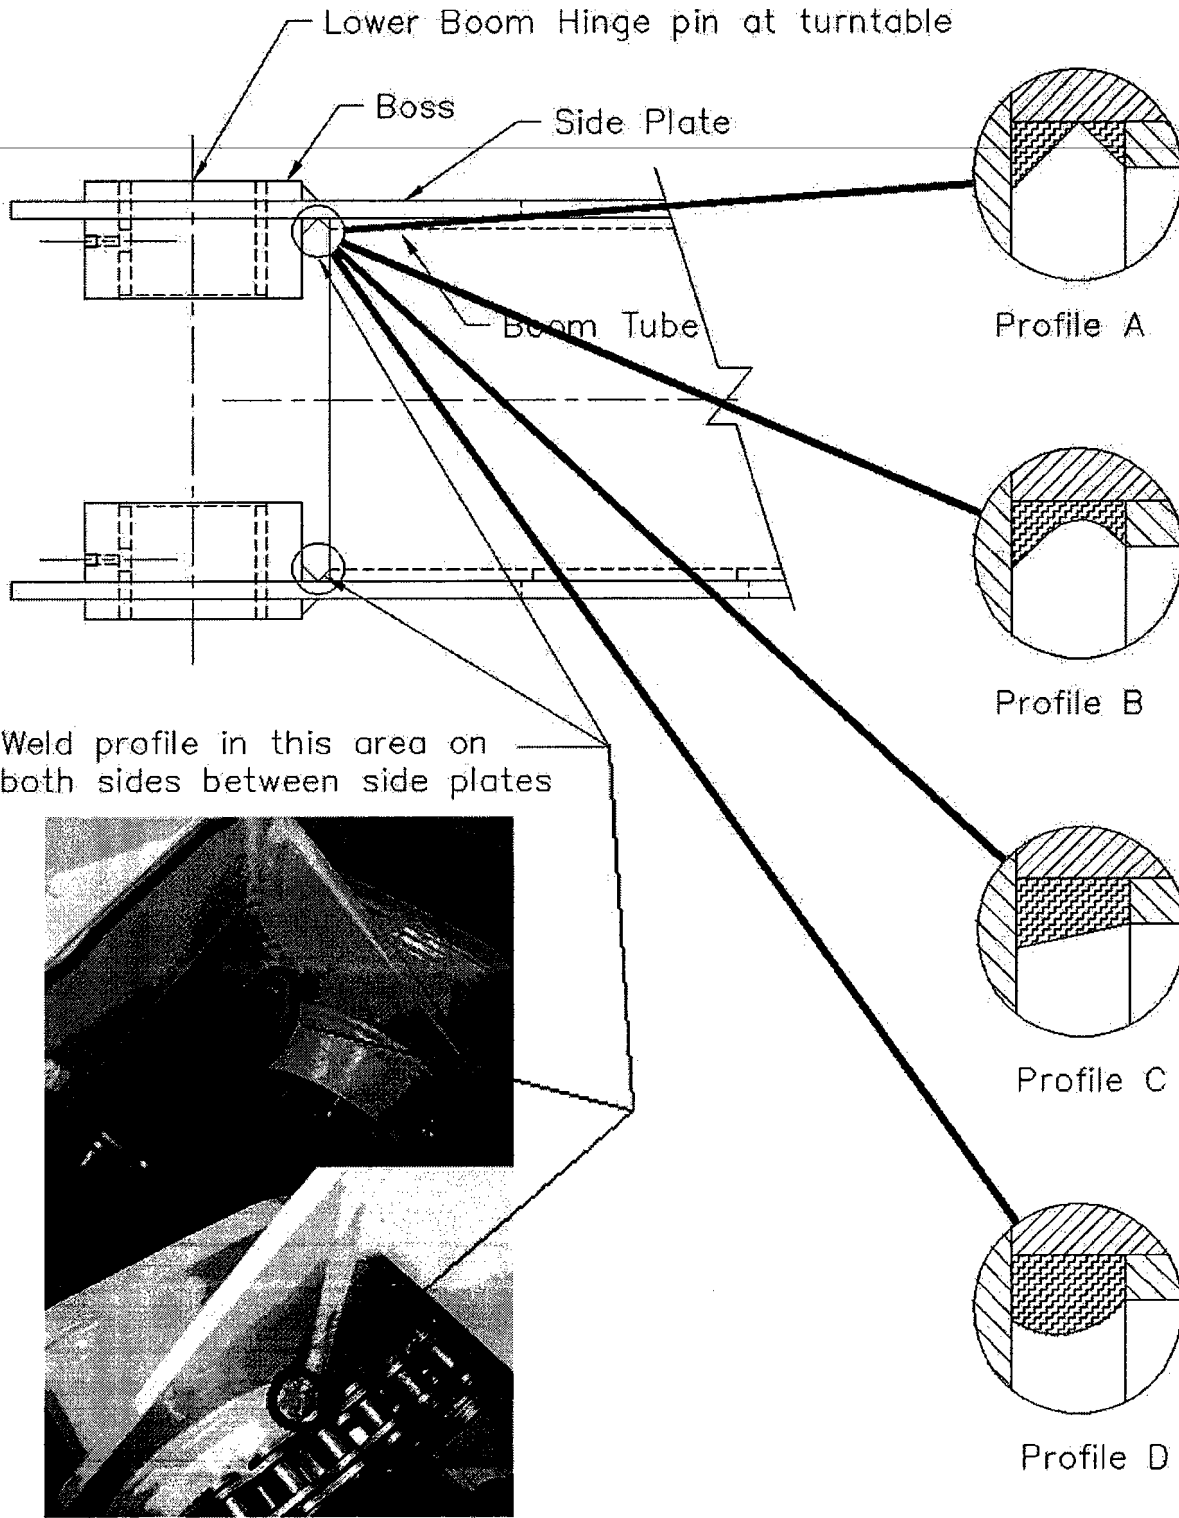
CB591 WELD INSPECTION PROFILE

COMPARE THE PROFILES OF THE WELDS INDICATED ABOVE ON YOUR MACHINE TO THE FOUR ZIG ZAG HATCH PATTERN ABOVE AND MARK ON THE FORM WHICH MOST CLOSELY MATCHES FOR BOTH SIDES.
