Recall 10V-100

## RECALL #10V-100

MODEL: C2

SUBJECT: AG2 AIR ENTRANCE DOOR POSITION SWITCH REPLACEMENT  
WITH 2-POSITION CONTROL SWITCH

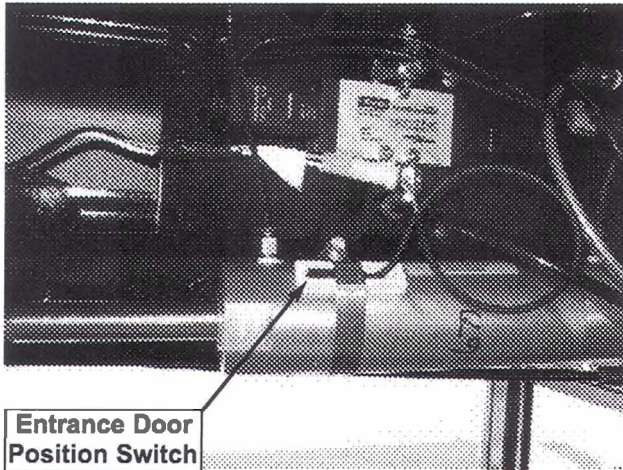
The defect involves the reed switch. The reed switch used to detect the position of air operated front entrance door may malfunction causing warning lights and crossing arm to operate improperly during student loading. Malfunctioning warning lights during the loading or unloading process could put students at risk of injury.

3. Locate the entrance door position switch clamped to the air actuator. **Figure 3**
4. Disconnect the entrance door position switch from the body harness by cutting the wires behind the connector. **Figure 4**
