Recall Campaign

May 2010
FL576A
NHTSA #10V-149

Copy of Letter to Owner Subject: Unimog Transverse-Control Arms

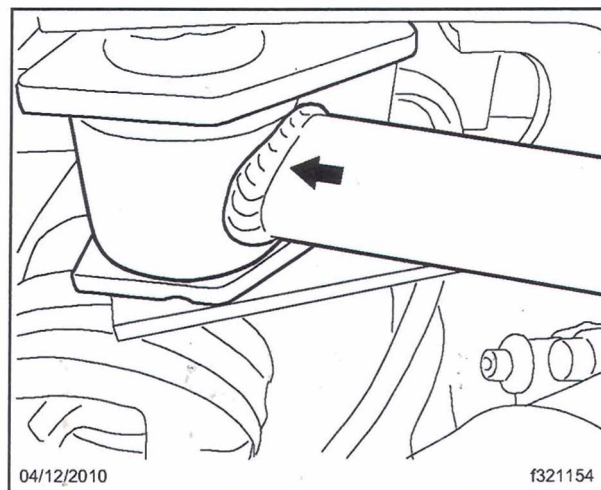
Fig. 1, Transverse-Control Arm Weld Area

A weld connecting the transverse-control arm eye to the control arm tube may not be to specification, potentially allowing the eye to separate from the tube without warning under severe driving conditions. Unexpected separation may cause a loss of vehicle control and possible vehicle crash and personal injury.

2. Park the vehicle on a level surface, shift the transmission to neutral, shut down the engine, and set the parking brake. Chock the tires.
3. On both the front steering axle and the rear axle, clean and inspect the weld seams at the transition of the transverse-control arm tube to the bolt eyes. See Fig. 1.

4. If the transverse-control arm is spot welded to the bolt eyes or there are cracks present, replace the arm. Go to "Transverse-Control Arm Replacement." It is expected that 2 percent or fewer control arms will require replacement.
