**R10RW**

# Incorrect Power Cable Lug Orientation

# RECALL

Models Affected: 2004 through 2009 Vision

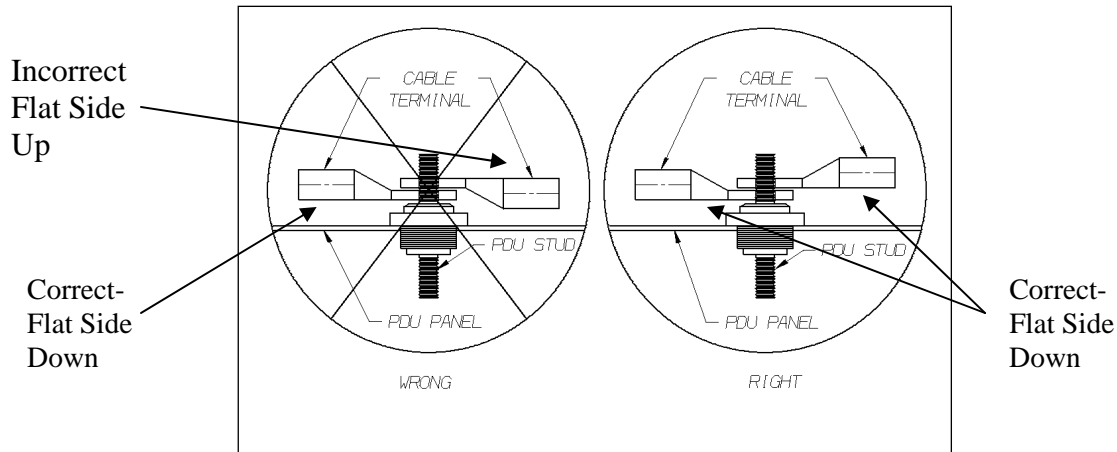
ALL terminal lugs on each power stud should be oriented such that the barrel of the lug is further away from the mounting surface of the isolated stud. The flat side must be down.

11. Remove the nut securing the cables. Then remove the incorrectly installed cables and reinstall correctly with flat side down. Make sure the terminal lugs are fanned out on the stud as oppose to directly on top of each other.
12. If needed, use vise grips to rotate cable so lug fits with flat side down. See photo on page 2.
13. Secure the cables with the nut and torque to 12 to 15 ft-lbs.
14. Apply corrosion resistant coating (glyptal) as required to prevent corrosion.
15. Reinstall the red protective covers.
16. While having access to this area, inspect ALL power cables for any evidence of contact with the rear of the engine, chaffing, or other damage. **Ensure clearance between power cables and any part of the engine is more than ½ inch.**
