Customer Service Notice

Date: October 25, 2010

Units Affected: WC126 and WC166 Chippers built after January 2008 and
All WC126A and WC166A Chippers

Frame and Axle Inspection

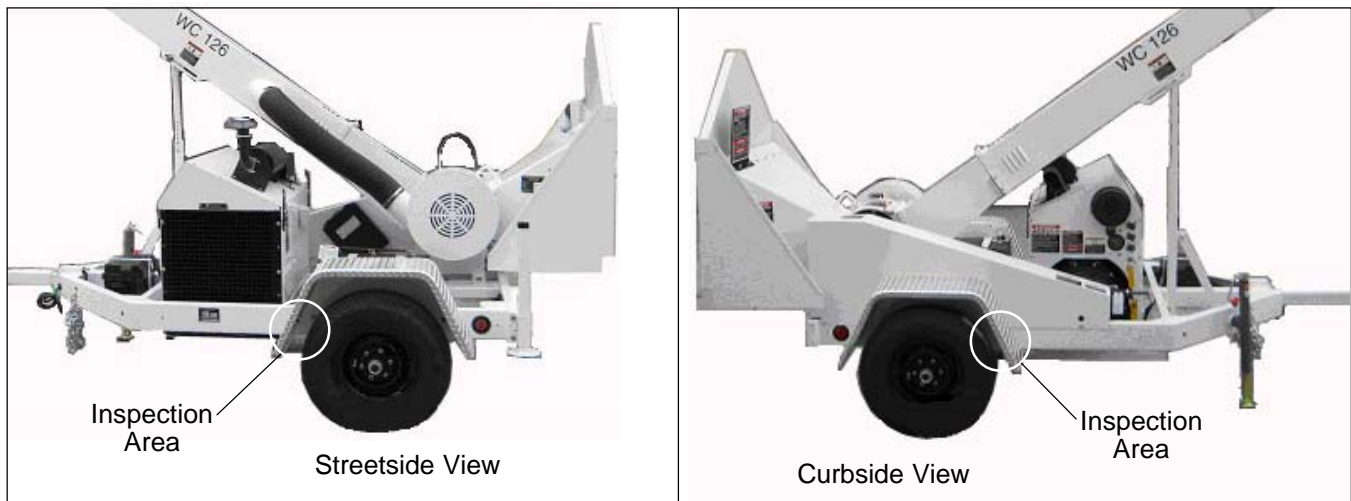
Figure 1 — Inspection Location

1. Position the chipper in a flat area where there is adequate light or an artificial light available to perform a careful inspection of the frame near the axle mounting (refer top Figure 1).

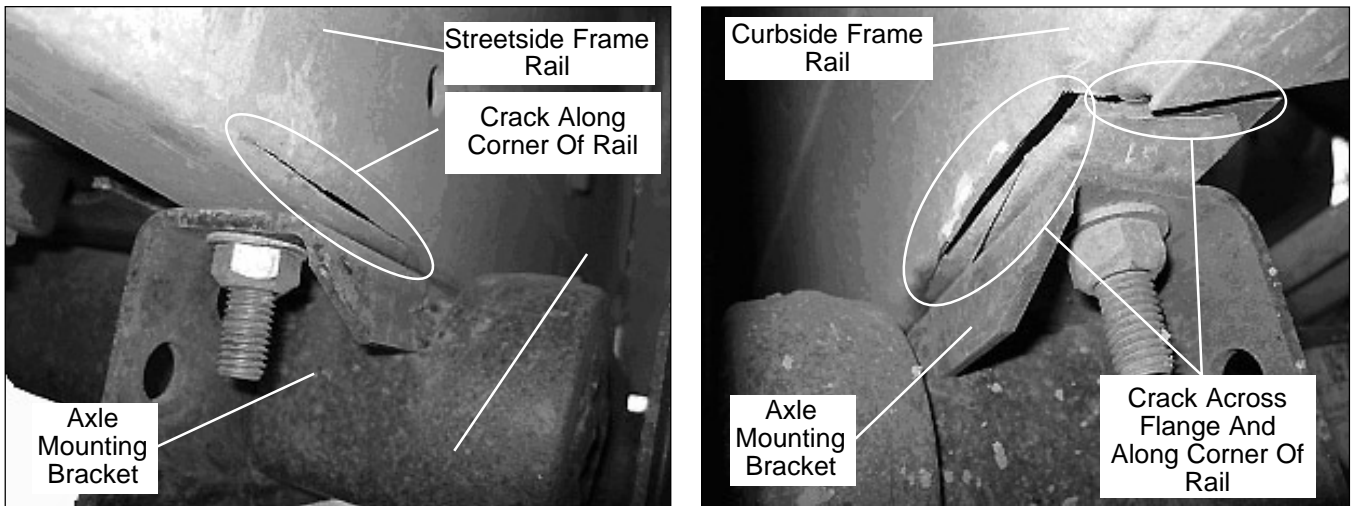
Figure 2 — Cracks Near The Axle Mounting

Some customers have reported cracks in the frame, frame failure or cracks in the axle attachment on the above listed chippers. The frame cracks have usually occurred just ahead of the axle mounting location on each side of the frame. The axle cracks have occurred in the axle mounting bracket.

2. Look at each side of the frame in the area just in front of the axle mounting. Look for any cracks or deformities in this area of the frame close to the axle mounting brackets (refer to Figure 2).

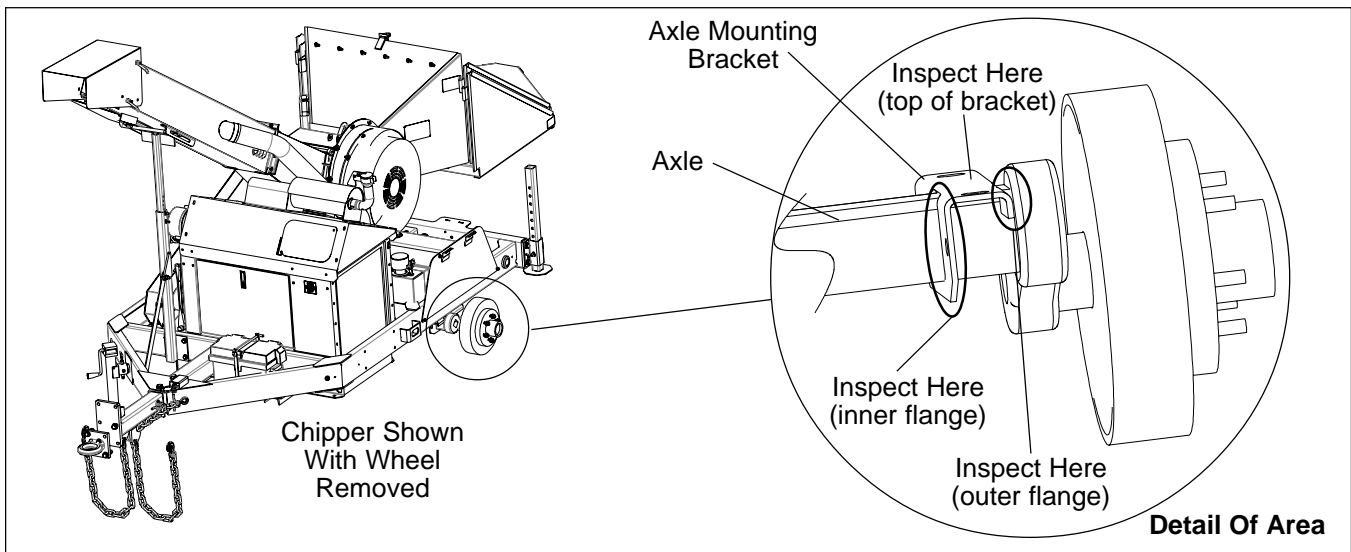
Figure 3 — Axle Mounting Inspection Area

3. Inspect each axle mounting bracket for any cracks on where the bracket mounts to the axle (refer to Figure 3). Look for any deformation in the mounting bracket (bent ears, top of bracket bent, etc.)

4. If there is a crack in the axle mounting bracket, the crack can be welded **ONLY** if **ALL** of the following are true:
- the crack in the axle mounting is only in the smaller (outer) flange of the mounting and no longer than 1½ inches (refer to Figure 3).
 - cracks do not appear on the larger (inner) flange of the mounting.
 - the axle bracket is not deformed or cracked.

If all of the above conditions are true, weld the crack starting the weld beyond the crack. Wrap the weld around the bracket so that the weld ends on the inside surface of the u-shaped axle mounting bracket. Daily inspections of this area must continue until Altec has made the final repair. If the axle bracket is cracked on the inner flange, cracked more than 1½ inches, or deformed, remove the unit from service immediately.

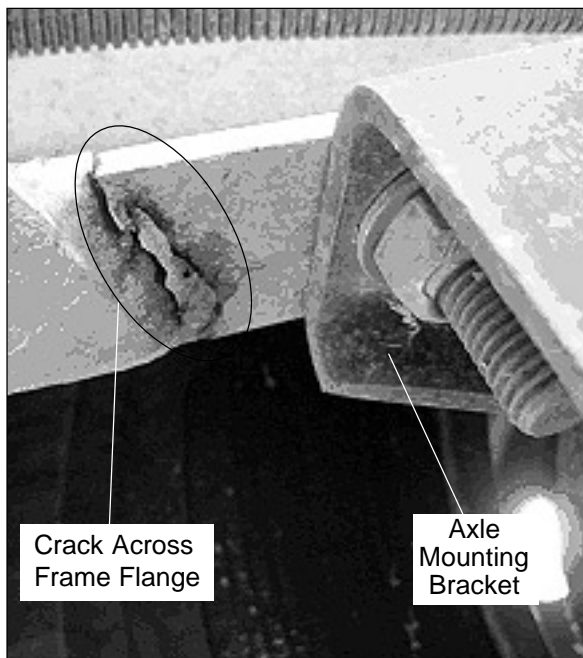
Figure 4 — Cracks Across The Bottom Of The Frame

5. Inspect each side of the frame near the fender mounting points for evidence of cracks (refer to Figure 4).
6. If there is a crack in the frame and it extends only across the flange of the frame rail and NOT across the web or along the corner of the frame rail (refer to Figure 5), the chipper can continue to be used, but a Frame Reinforcement Kit must be installed. The frame must be inspected at the beginning of each shift for growth of the crack. If the crack extends through the smaller (outer) flange of the mounting completely away from the axle tube, take the unit out of service immediately. To return the unit to service temporarily, the cracks may be welded closed by a qualified welder. Daily inspections of this area must continue until Altec has made the final repair.
