# Customer Service Notice

Date: December 1, 2010

Units Affected: AT35-G and AT37-G Units Manufactured With Insulating Arm Links  
(Serial numbers 1197DE0101 through 0508DE9620)

## Articulating Arm Fiberglass Link Inspection

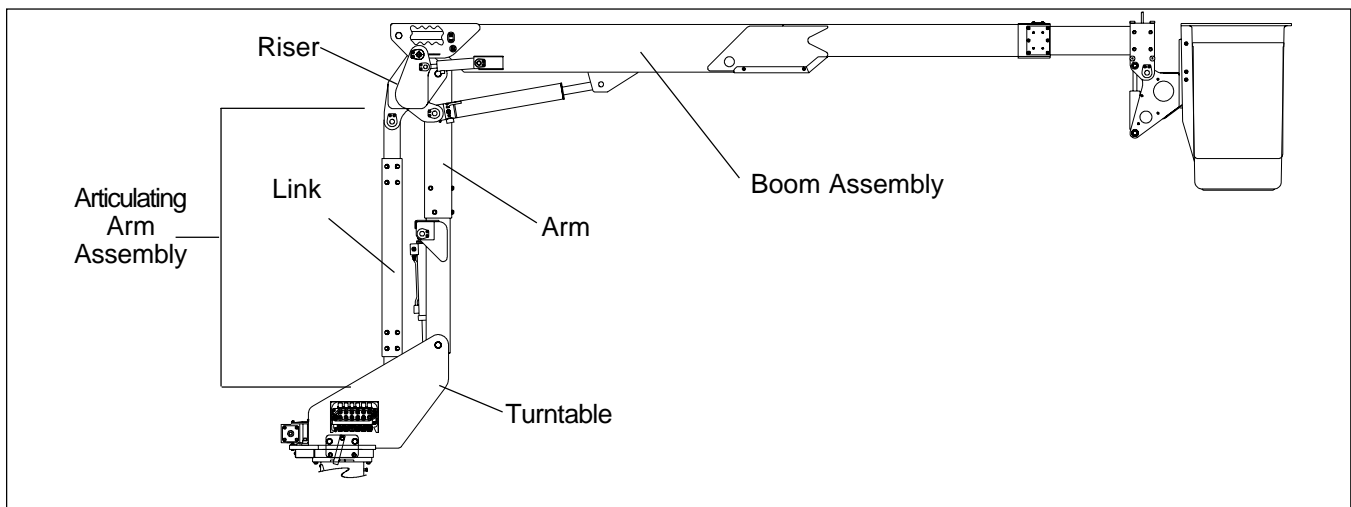
*Figure 1— Fiberglass Link and Arm*

The link is a part of the articulating arm assembly on the above units (refer to Figure 1). It connects to the turntable and the riser and helps maintain the correct position of the boom and platform during use.

The link is made of a fiberglass tube with steel ends glued into the tube. Cap screws are used at each end to help secure the joint. Altec has received reports of glue bond separation at the fiberglass to steel joint on the articulating arm fiberglass link. **Death or serious injury can result from falling from the platform. Failure of the articulating arm fiberglass link can cause falling from the platform.**

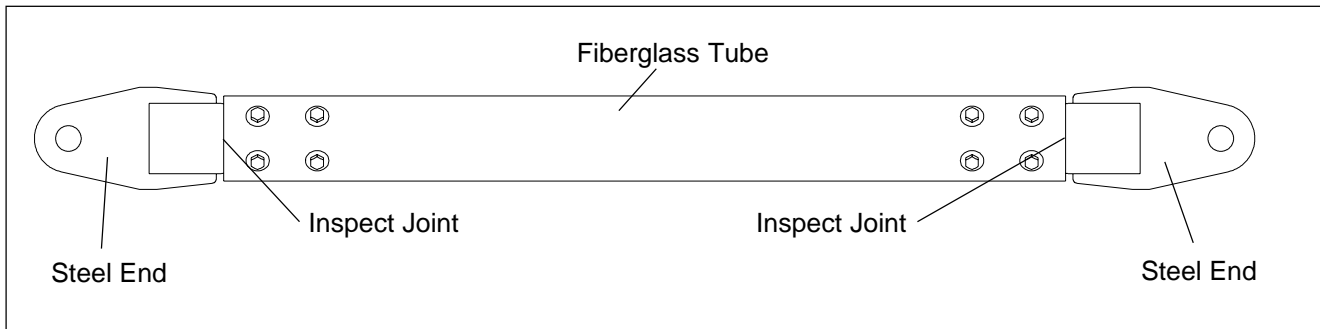
**Figure 2 — Link Inspection Areas**

1. Position the unit on a level surface, apply the parking brake and chock the wheels. Engage the unit's hydraulic system. Properly set the outriggers (if so equipped).
2. Use the lower controls and raise the lower boom out of the rest one to two feet.
3. The areas for the link inspection are at each end of the fiberglass where it joins the steel end (refer to Figure 2). Watch this area while performing Steps 6 and 7.

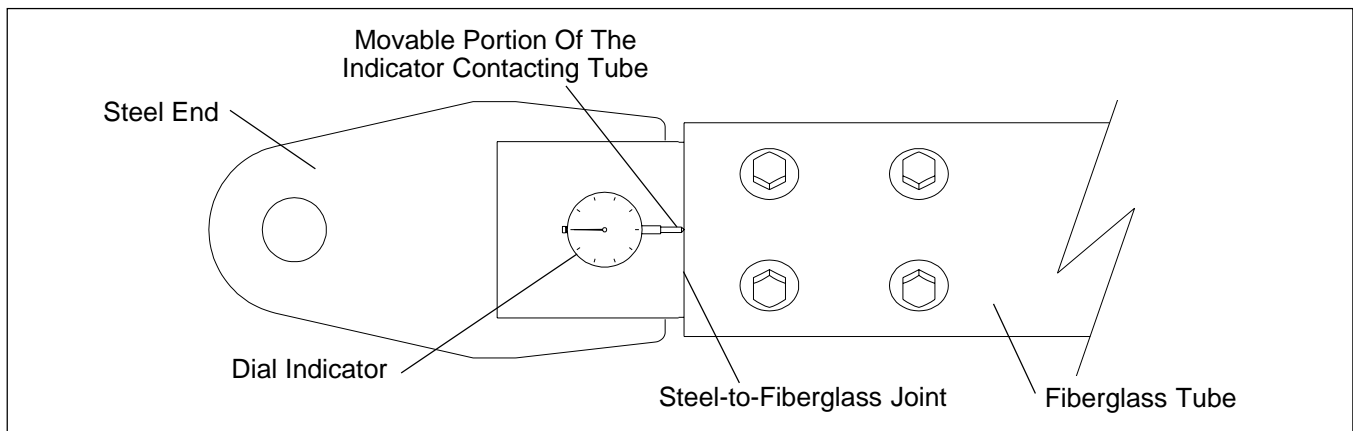
**Figure 3 — Dial Indicator Placement**

4. Fasten a dial indicator onto the steel end at one end of the link (refer to Figure 3). Figure 3 shows the basic orientation of the dial indicator. The actual installation and position of the dial indicator will vary depending on size and style of attachment. Make sure the movable portion of the dial indicator is positioned so that it is firmly in contact with the end of the fiberglass tube.

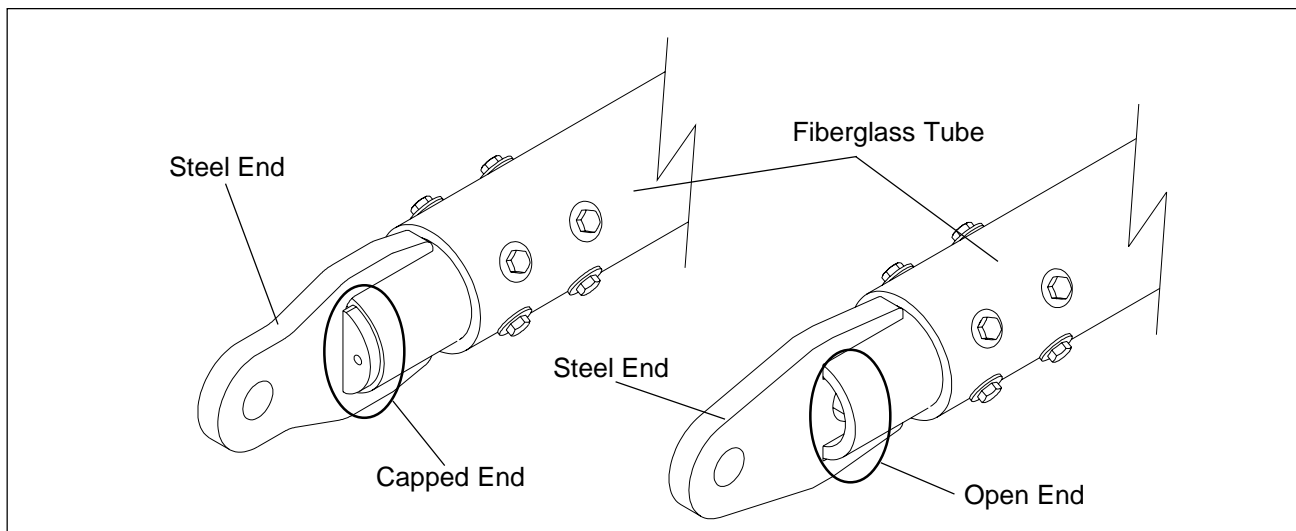
**Figure 4 — Link Style**

**Movement between .020 inch and .125 inch at either end of the link:**

- Determine whether the steel end weldments of the link are open or capped (refer to Figure 4).

- Order the 970270320 Link Through Bolt Kit. Follow the instructions included with the kit to install the reinforcing bolts that are supplied in the kit.

- Order 970276836 Link Replacement Kit (AT35-G) or 970276837 Link Replacement Kit (AT37-G) and install.
