**Re: Defect Information Report – Supplemental Report No. 2
10E-005 (10C-2) & 10V-112 (FL-575), S60 DPF Over Temp Shutdown**

Subject: **Safety Recall 10C2**
Series 60 EPA07 MCM Reprogramming in Fire Truck Applications

SAFETY RECALL BULLETIN

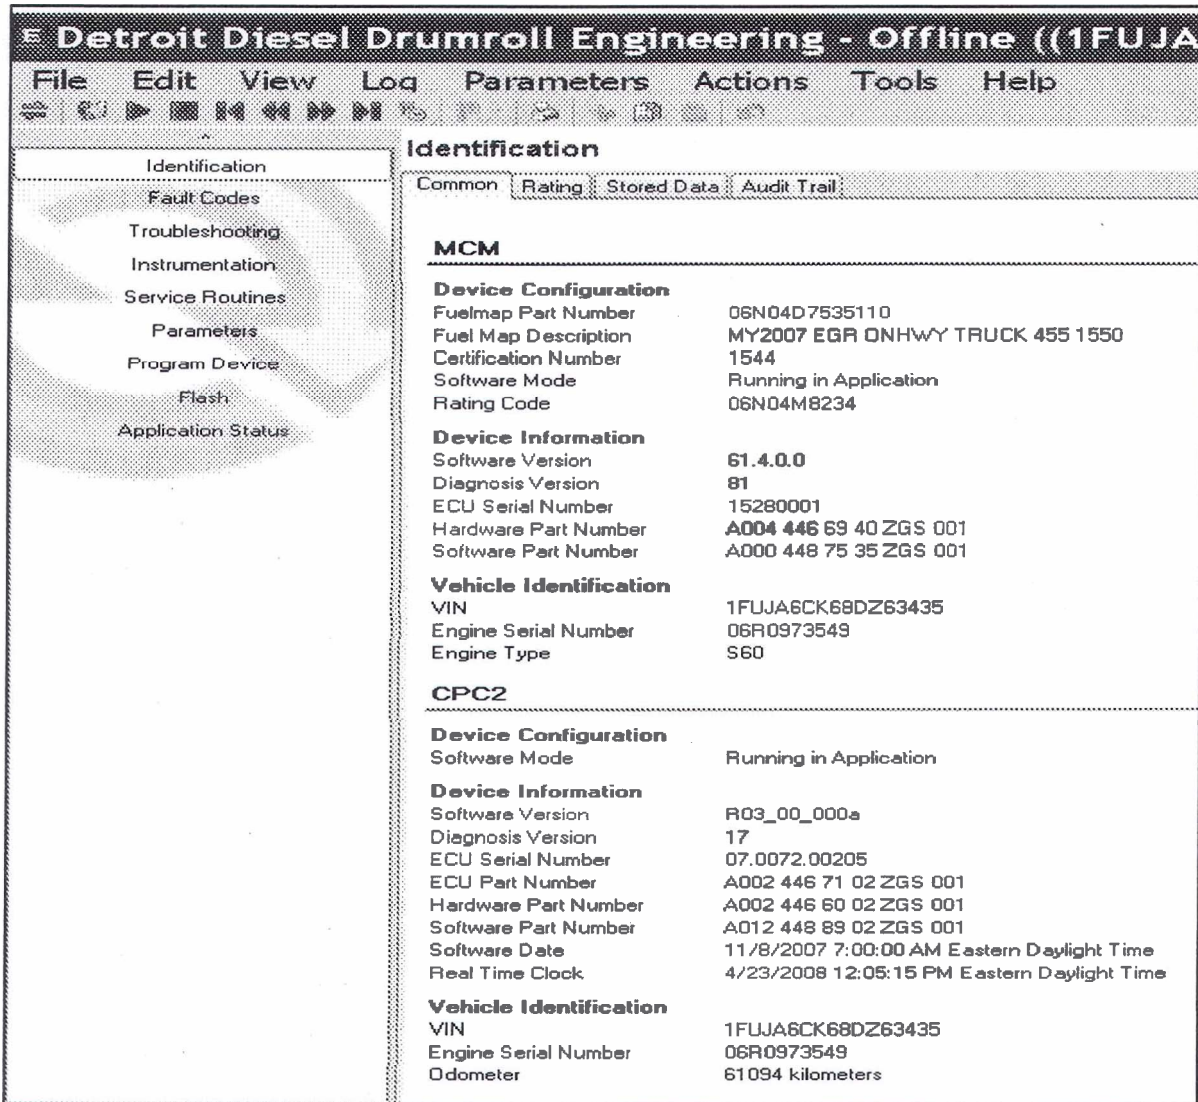
Figure 1 – Software and Fuel Map Version Number

4. If the MCM is not at software v62.6.0.0 with fuel map version 114 or higher, program it to v62.6.0.0 or higher using the "Update Device Software" option. Select "No Charge", then "Description", and enter "10C2" in the "Provide Reference" box.
5. Using the "Identification" screen in DDRS 7.04, check the CPC software level. See Figure 1. In this example, the CPC software level is r3.00. If the CPC is not at r4.03 software or higher, program it to r4.03 using the "Update Device Software" option. Select "No Charge", then "Description", and enter "10C2" in the "Provide Reference" box.
