ITB10-028

May 20, 2010

VOLUNTARY SAFETY RECALL CAMPAIGN 2010 QX56 SUSPENSION LOWER LINK

CAMPAIGN ID #: PC048
NHTSA # 10V-208
APPLIED VEHICLES: 2010 QX56 (JA60)

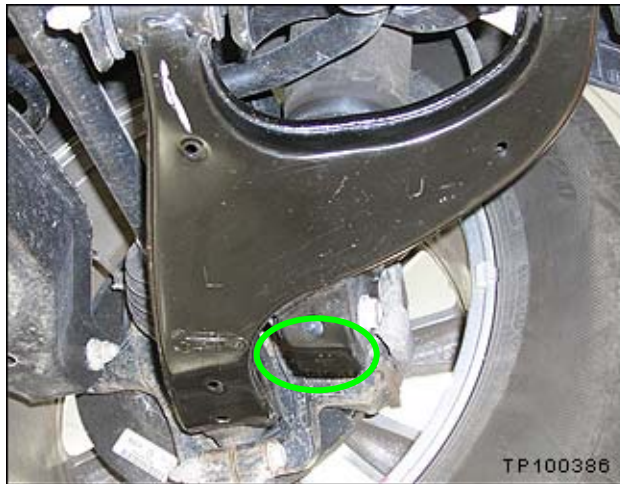
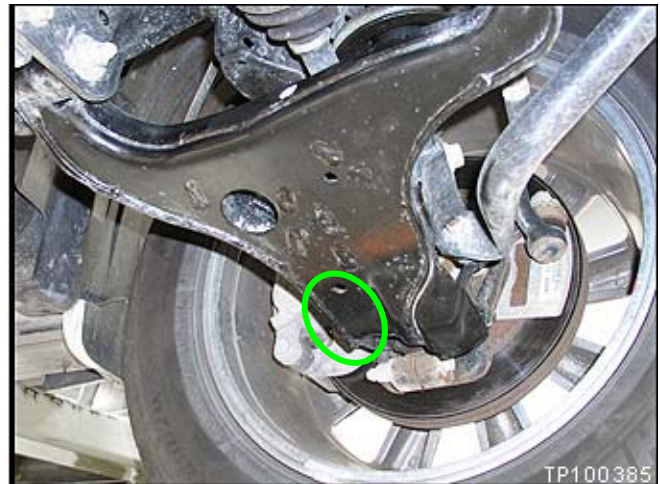
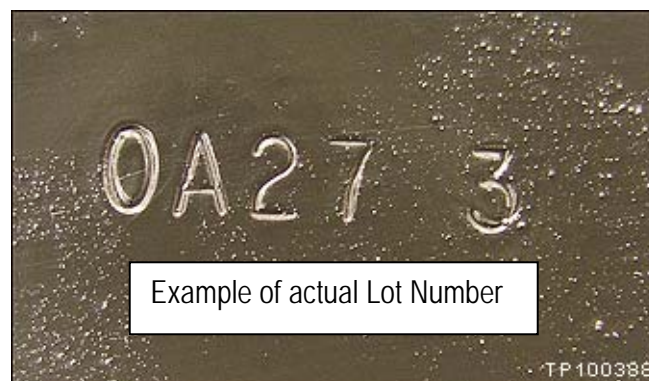
1. Raise the vehicle.
2. Locate and write down the "Lot Number" stamped on the bottom side of the suspension lower links.
 - Refer to the Lot Number Locations below.
 - Inspect front and rear (all 4) lower links.
3. Compare the Lot Number of each lower link to the Lot Number examples on the next page.
