# RECALL CAMPAIGN BULLETIN

NTB10-071a

## VOLUNTARY SAFETY RECALL CAMPAIGN EQUIPMENT / SERVICE PARTS SUSPENSION LOWER LINK

**CAMPAIGN ID #:** PC049  
**NHTSA #** 10E-019  
**APPLIED VEHICLES:** 2004 - 2010 Armada (TA60)  
2004 - 2010 Titan (A60)  
2005 - 2010 Frontier (D40)  
2005 - 2010 Pathfinder (R51)  
2005 - 2010 Xterra (N50)

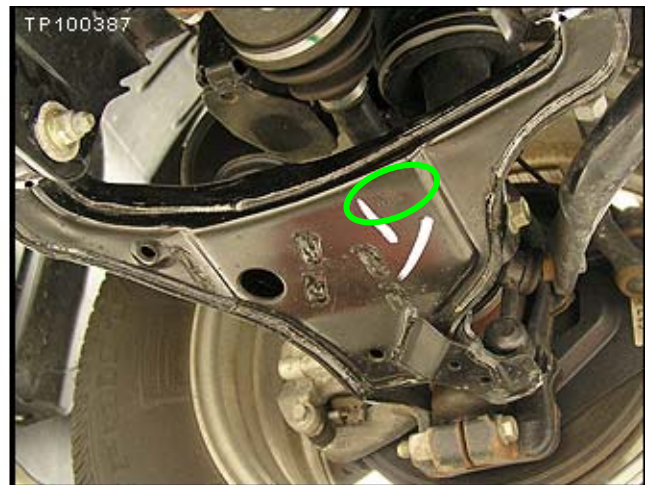
Front: Armada and Titan

1. Raise the vehicle.
2. Locate and write down the “Lot Number” stamped on the bottom side of the suspension lower links.
  - Refer to the Lot Number Locations below.
  - Armada and Pathfinder: Inspect front and rear (all 4) lower links.
  - Frontier, Titan, and Xterra: Inspect both front lower links.
3. Compare the Lot Number of each lower link to the Lot Number examples on the next page.
