ITB10-033

June 23, 2010

VOLUNTARY SAFETY RECALL CAMPAIGN EQUIPMENT / SERVICE PARTS SUSPENSION LOWER LINK

CAMPAIGN ID #: PC050
NHTSA# 10E-019
APPLIED VEHICLES: 2004 - 2010 QX56 (JA60)

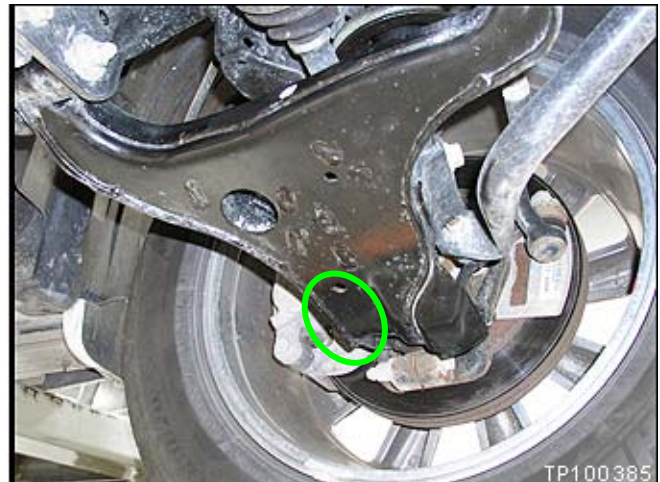
Rear

1. Raise the vehicle.
2. Locate and write down the "Lot Number" stamped on the bottom side of the suspension lower links.
 - Refer to the Lot Number Locations below.
 - Inspect front and rear (all 4) lower links.
3. Compare the Lot Number of each lower link to the Lot Number examples on the next page.
