# RECALL CAMPAIGN BULLETIN

NTB10-071

June 23, 2010

## VOLUNTARY SAFETY RECALL CAMPAIGN EQUIPMENT / SERVICE PARTS SUSPENSION LOWER LINK

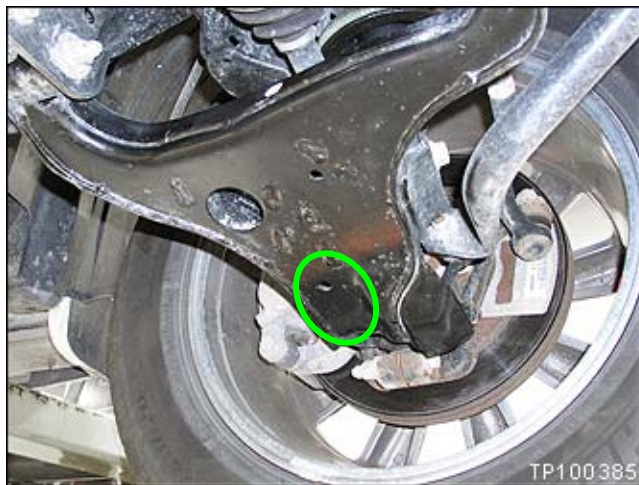
Front: Armada and Titan

1. Raise the vehicle.
2. Locate and write down the “Lot Number” stamped on the bottom side of the suspension lower links.
  - Refer to the Lot Number Locations below.
  - Armada and Pathfinder: Inspect front and rear (all 4) lower links.
  - Frontier, Titan, and Xterra: Inspect both front lower links.
3. Compare the Lot Number of each lower link to the Lot Number examples on the next page.
