April 2010

Dealer Service Instructions for:

Customer Satisfaction Notification J38 Supplemental Front Airbag Sensors

2005-2006 (RS) Dodge Caravan, Grand Caravan and Chrysler Town & Country

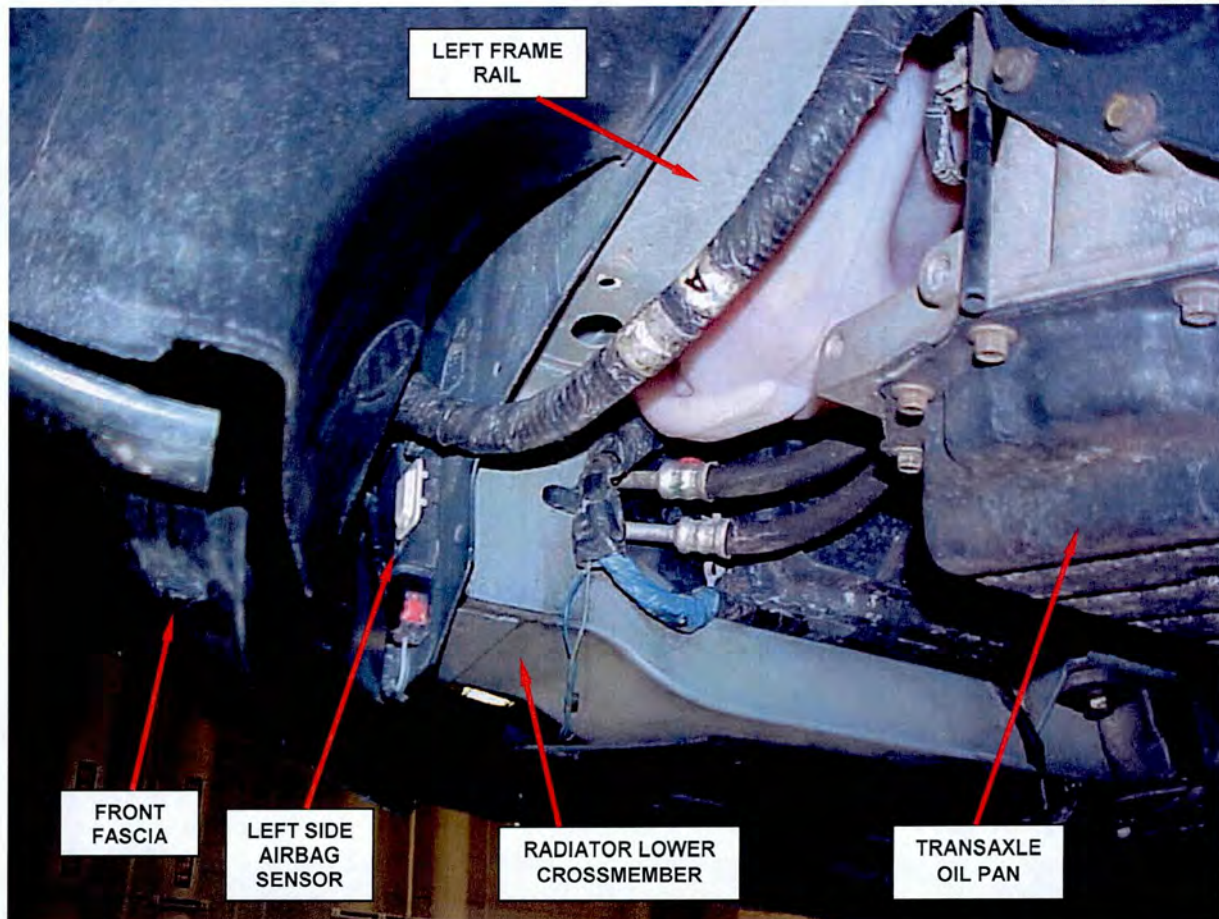
Figure 1 – Left Side Airbag Sensor Shown

The supplemental front airbag sensors on about 310,000 of the above vehicles may crack under certain conditions and allow water to enter into the sensor. These sensors were added to enhance the performance of the vehicle's airbag system; however, a cracked sensor may not operate properly in a frontal crash. A cracked sensor can also illuminate the airbag warning light.

The right and left supplemental front airbag sensors must be replaced and the sensor wiring harness connectors must be inspected and replaced, if necessary.

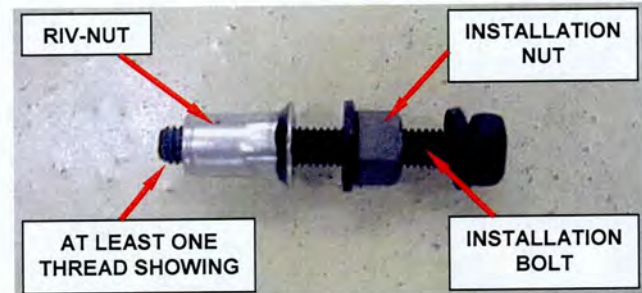
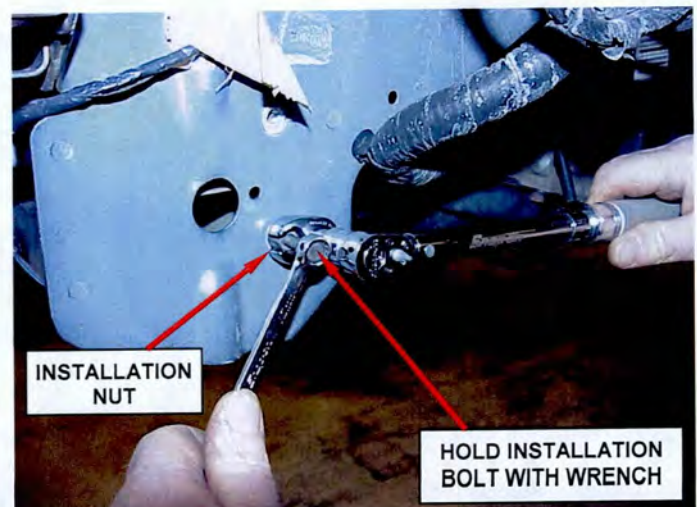
Figure 4 – Riv-Nut Installation

CAUTION: If the retaining bolt spins freely and cannot be removed, the sensor's riv-nut has broken loose from the radiator lower crossmember. Continue with Step 7 to install a new riv-nut (PN CBX2G093). If there was no problem when removing the sensor retaining bolts, continue with Step 9.

- n. Pre-assemble the new riv-nut by installing the installation nut and the riv-nut onto the installation bolt as shown in Figure 4.
- o. Insert the new riv-nut-bolt/nut assembly into the original riv-nut hole in the lower radiator crossmember.

- p. Using a 10mm crows foot, tighten the installation nut to 80 in. lbs. (9 N·m) while holding the head of the installation bolt stationary (Figure 5).
- q. Loosen the installation nut and remove the installation bolt and nut from the riv-nut.
- r. Repeat Steps 7i through 7q for each airbag sensor mounting riv-nut that has broken loose (spins freely).
