Recall Bulletin

PRODUCT SAFETY RECALL

SUBJECT: Accelerator Pedal Sticking

MODELS: 2009-2010 Pontiac Vibe

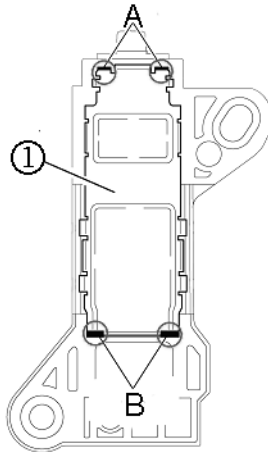
2394601

View: Back-side of Pedal Assembly (1) Accelerator Link Arm Support Cover (A) Gaps (B) Gaps

5. Remove the accelerator link arm support cover using a pocket screwdriver. Evenly and lightly pry up on gaps (A) and then gaps (B) to remove the cover. Refer to illustration.
