TEREX

CAMPAIGN BULLETIN

01-591-10

SUBJECT: *Weld inspection XT60 Lower Boom*

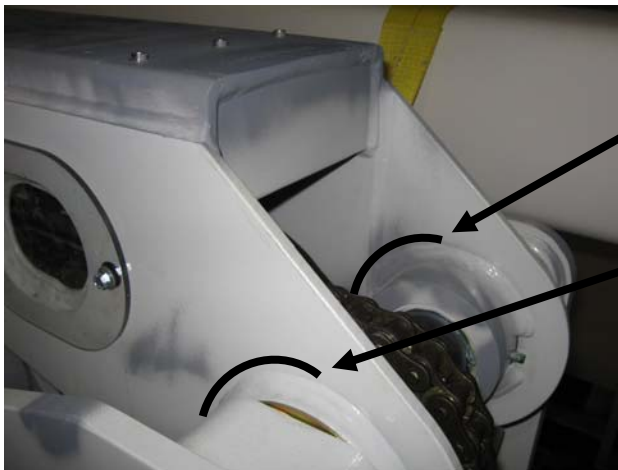
TEREX Utilities has received reports of cracks in the welds that have progressed into failure of the side plate at the lower boom hinge pin on XT60 aerials. The failure originates at the joint between the boom tube and pivot boss in the side plates. **The failure of the plates will cause unexpected motion of the boom and possible falling of the platform.**

Inside on both sides

Outside on both sides

Inspect the areas all around the boss on the inside and outside of boom on both side plates.

Immediately inspect for cracks in or near the welds of the lower boom side plates shown below before further use of the machine.

1. Clean the area around the boss.
2. Perform a visual inspection for cracks in the areas shown below.

- **If any cracks are detected do not continue to operate the unit, take it out of service immediately.** Send in the completed form and contact TEREX Utilities at 605-884-3892 to arrange repairs before further use.
