TECHNICAL INSTRUCTIONS
FOR
SAFETY RECALL ALA
ABS ACTUATOR ECU UPDATE
2010 MODEL YEAR HS 250h
REVISED FEBRUARY 18, 2010

SAFETY RECALL ALA

ABS ACTUATOR ECU UPDATE

2010 MODEL YEAR HS 250h

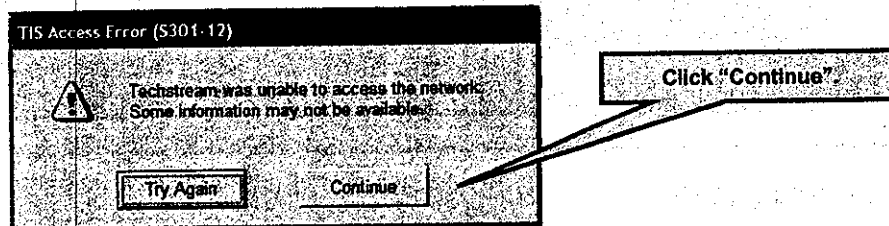
- The Health Check function can not be used to confirm ALA applicability when the Techstream is operated outside of dealership network range.
- When outside of dealership network range, you may see the following error screen.

- Calibration update applicability can be checked using the Calibration Update Wizard (CUW) as shown in steps 1-3 below and on the next page.
