TECHNICAL INSTRUCTIONS

SAFETY RECALL A0D

FRONT PROPELLER SHAFT INSPECTION

2010 MODEL YEAR TACOMA 4WD

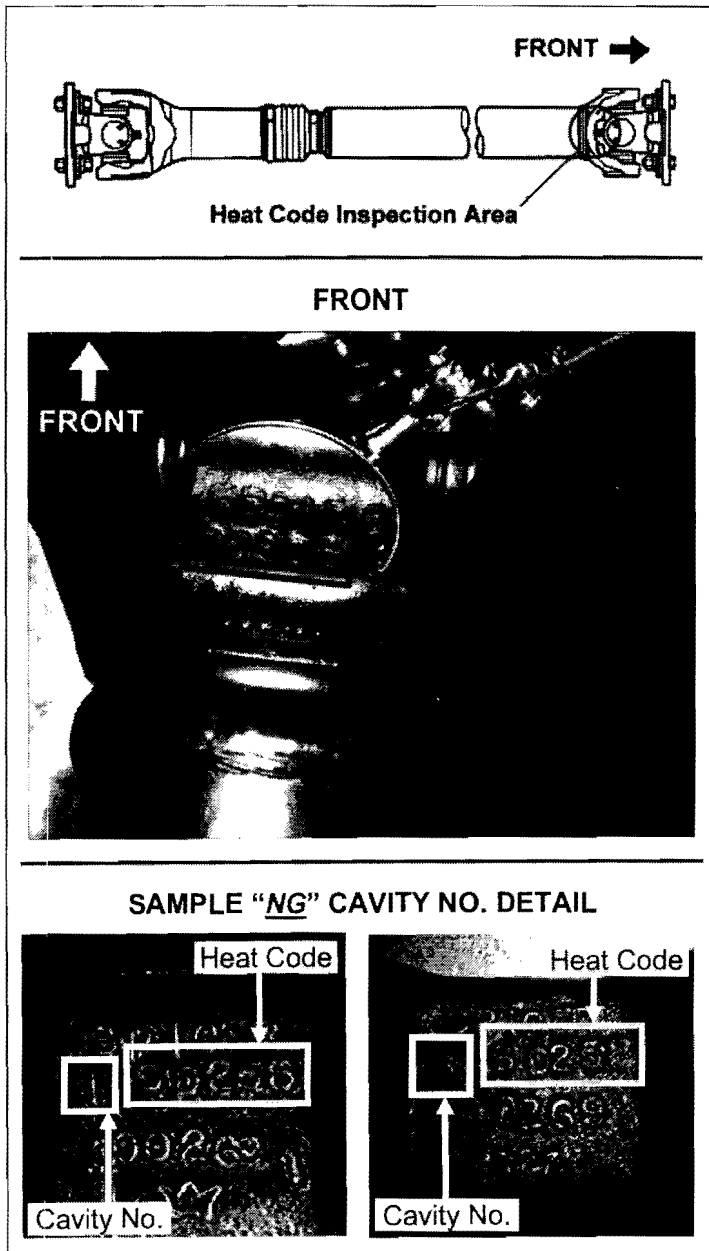
1. CONFIRM THE HEAT CODE AND CAVITY NO.

- a) Using a telescoping mirror and flashlight, locate the 5 digit Heat Code and 1 digit Cavity No. stamped on the front end of the front propeller shaft as shown in the illustrations.

The front propeller shaft may need to be rotated 180° to see the Heat Code and Cavity No.

- b) Does the front propeller shaft have a Heat Code of SD258 or SD231?

- c) Does the front propeller shaft have a Cavity No. of 1 or 3?

The front propeller shaft is NG / affected, Proceed to APPENDIX "A" for "FRONT PROPELLER SHAFT REPLACEMENT".

- a) Replace the **“Front Propeller Shaft”** and install a **NEW** one as outlined in the repair manual (TIS keyword: “Front Propeller Shaft Assembly”).
- b) Campaign completed
