Recall Campaign

March 2010
FL572A
NHTSA #10V-053

Subject: Sheppard Pitman Arm Restraining Washers

Models Affected: Specific Freightliner Cascadia vehicles manufactured May 13, 2009, through January 26, 2010, in Saltillo, Mexico, with Sheppard pitman arms.

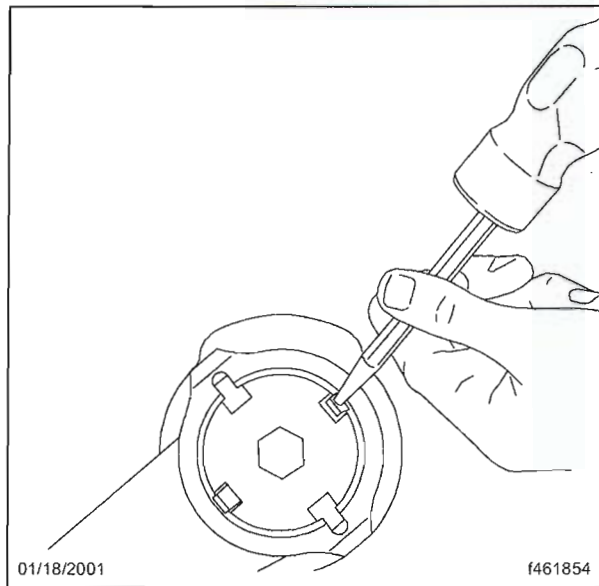
Fig. 1, Bending the Restraining Tabs

If the tabs are not seated correctly in the retainer, proceed to the next step.

6. Using a punch and hammer, bend the two restraining tabs of the washer into the notches on the retainer. See Fig. 1. Apply torque seal, OGP F900WHITE, to the tabs.
7. Clean a spot on the base label (Form WAR259), write the recall number, FL572, on a blank red completion sticker (Form WAR260), and attach it to the base label.
