Safety Recall Trucks

Date	Number	Page
09/4/09	SC0341	1(5)

SC0341, Front Axle Beam

This bulletin replaces the safety recall bulletin dated 8/12/09.

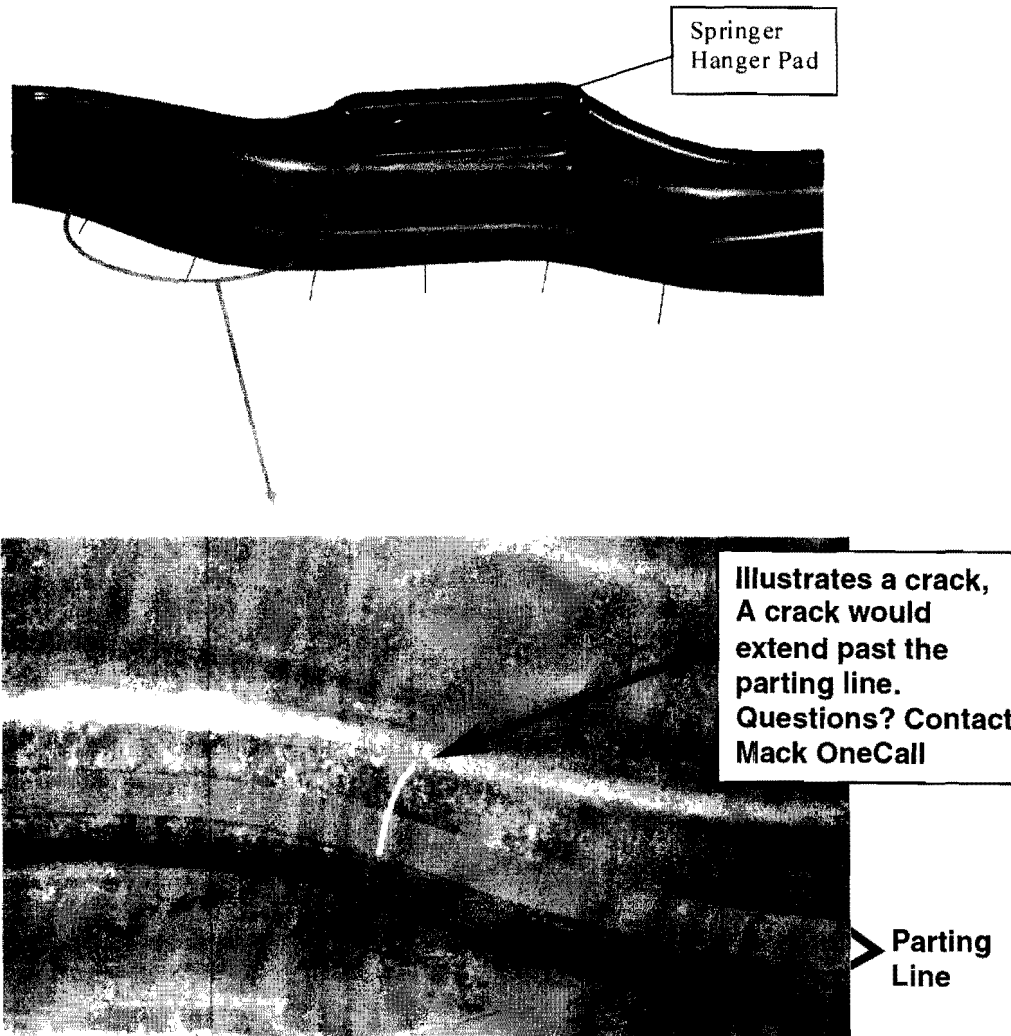
On certain vehicles manufactured from October 1, 2003 through September 30, 2004, the axle beam may have transverse notches from the manufacturing process, which may lead to a fatigue crack that can possibly result in an axle beam failure.

- Inspection Area:** The inspection area will be a two foot wide section on both the driver side and passenger side on the bottom of the axle centered on the spring hanger pad. A marker can be used to identify these sections prior to the cleaning and inspection.

Example of inspection area and axle beam

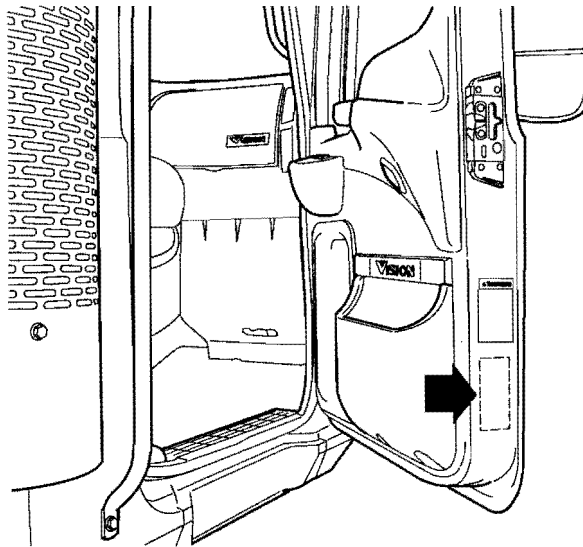
703153a

To signify that the campaign has been completed, use a permanent-type marker (such as a Sharpie®) to write the campaign number (SC0341) and completion date in the spaces provided on the Campaign Completion Label located on the lower edge (below the door latch) of the passenger-side door. If a label is not already affixed to the door, apply a label (part No. TS897) and supply the information as required. Campaign Completion labels are available in packs of 50 and can be ordered by faxing a completed BR313 to Pacesetters Business Services at 610-264-9465.
