# HYUNDAI Technical Service Bulletin

Subject <b>FRONTDOORLATCHINSPECTION (CAMPAIGN 096)</b>	Group CAMPAIGN		
	Number 10-01-016		
	Date MARCH, 2010		
Model 2011MY SONATA (YF)			
<b>CIRCULATE TO:</b>	<input type="checkbox"/> GENERAL MANAGER	<input checked="" type="checkbox"/> PARTS MANAGER	<input checked="" type="checkbox"/> TECHNICIAN
<input checked="" type="checkbox"/> SERVICE ADVISOR	<input checked="" type="checkbox"/> SERVICE MANAGER	<input checked="" type="checkbox"/> WARRANTY MGR	<input type="checkbox"/> SALES MANAGER

- This bulletin describes the procedure for the front latch assembly inspection and if necessary, replacement.

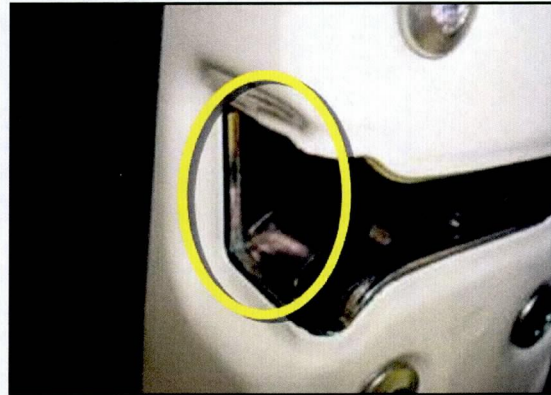
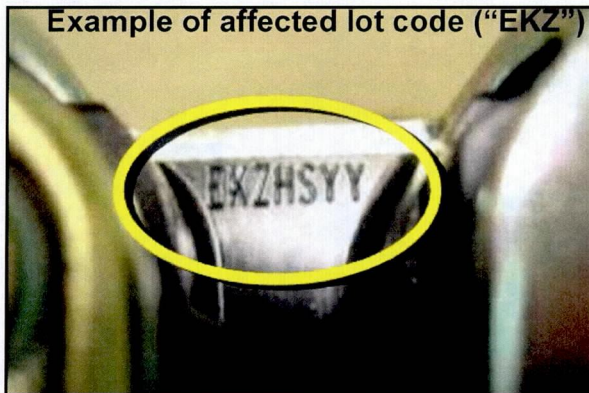
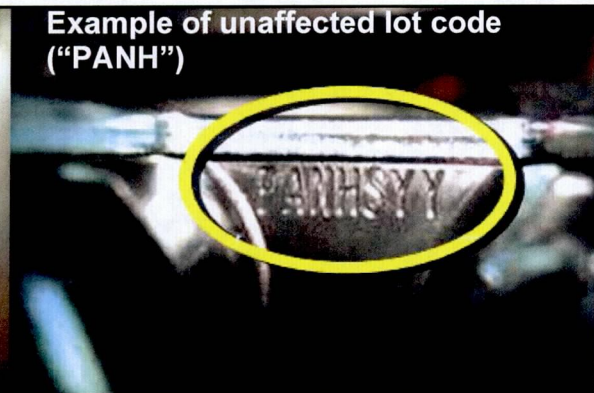
1. Open the left front door and inspect the latch lot code stamped on the inner latch assembly.

2. If the latch lot code begins with the following three (3) characters:
  - EJ (any third letter or any third number)
  - EK (any third letter or any third number)
  - ELA
  - ELB
  - ELC
  - ELD
  - ELE
  - ELF

proceed to the REPLACEMENT section.
