<b>HYUNDAI</b> Drive your way™	<b>DCS</b>	Model	
		Group	General Information
		No.	5001874
Subject <b>Service Campaign TA7 – 2011 MY Sonata Front Door Latch Inspection and Replacement – TSB# 10-01-012</b>	Published	2/25/2010	
	Modified

Subject <b>FRONT DOOR LATCH INSPECTION WITH REPLACEMENT (SERVICE CAMPAIGN TA7)</b>		Group CAMPAIGN	
		Number 10-01-012-1	
		Date FEBRUARY, 2010	
		Model 2011MY SONATA (YF)	
<b>CIRCULATE TO:</b>	<input type="checkbox"/> GENERAL MANAGER	<input checked="" type="checkbox"/> PARTS MANAGER	<input checked="" type="checkbox"/> TECHNICIAN
<input checked="" type="checkbox"/> SERVICE ADVISOR	<input checked="" type="checkbox"/> SERVICE MANAGER	<input checked="" type="checkbox"/> WARRANTY MGR	<input type="checkbox"/> SALES MANAGER

This bulletin provides instructions for the inspection and, if necessary, replacement of the Sonata (YF) front door latch assemblies.

Model: 2011MY SONATA (YF)

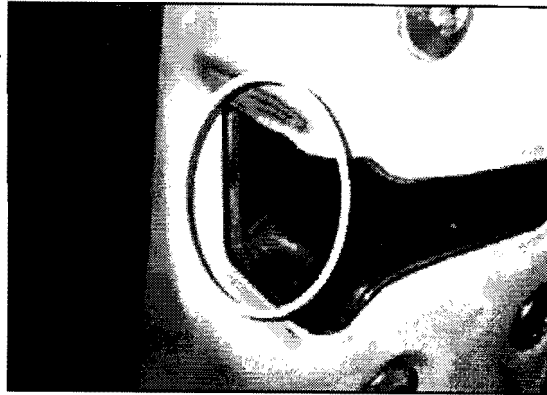
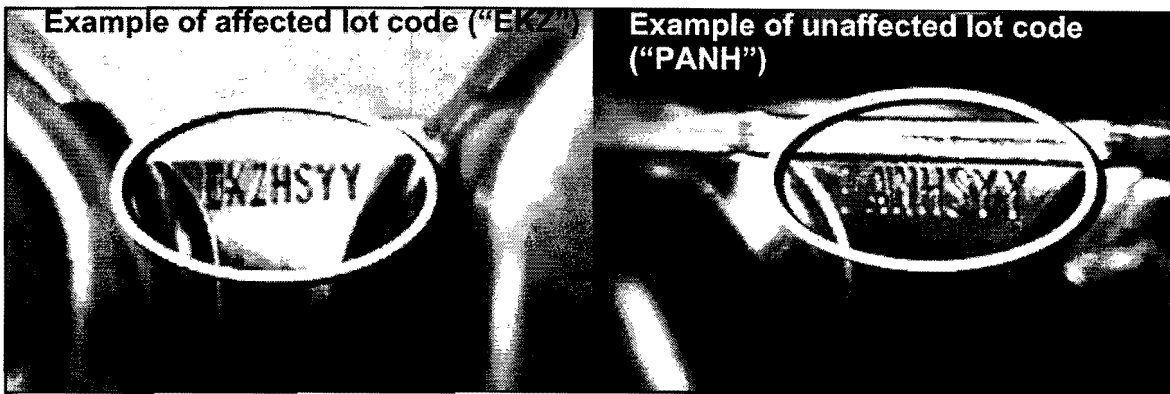
1. Open the left front door and inspect latch lot code stamped on inner latch assembly.

2. If the latch lot code begins with the following three (3) characters:

- EJ (any third letter)
- EK (any third letter)
- ELA
- ELB
- ELC
- ELD
- ELE
- ELF

proceed to the REPLACEMENT section.
