# Recall Bulletin

## PRODUCT SAFETY RECALL

**SUBJECT: Loss of Power Steering Assist – Replace Electric Power Steering Motor**

**MODELS: 2005-2010 Chevrolet Cobalt  
2005 Pontiac Pursuit  
2005-2006 Pontiac G4  
2006 Pontiac G5 Pursuit  
2007-2010 Pontiac G5  
Equipped with Electric Power Steering**

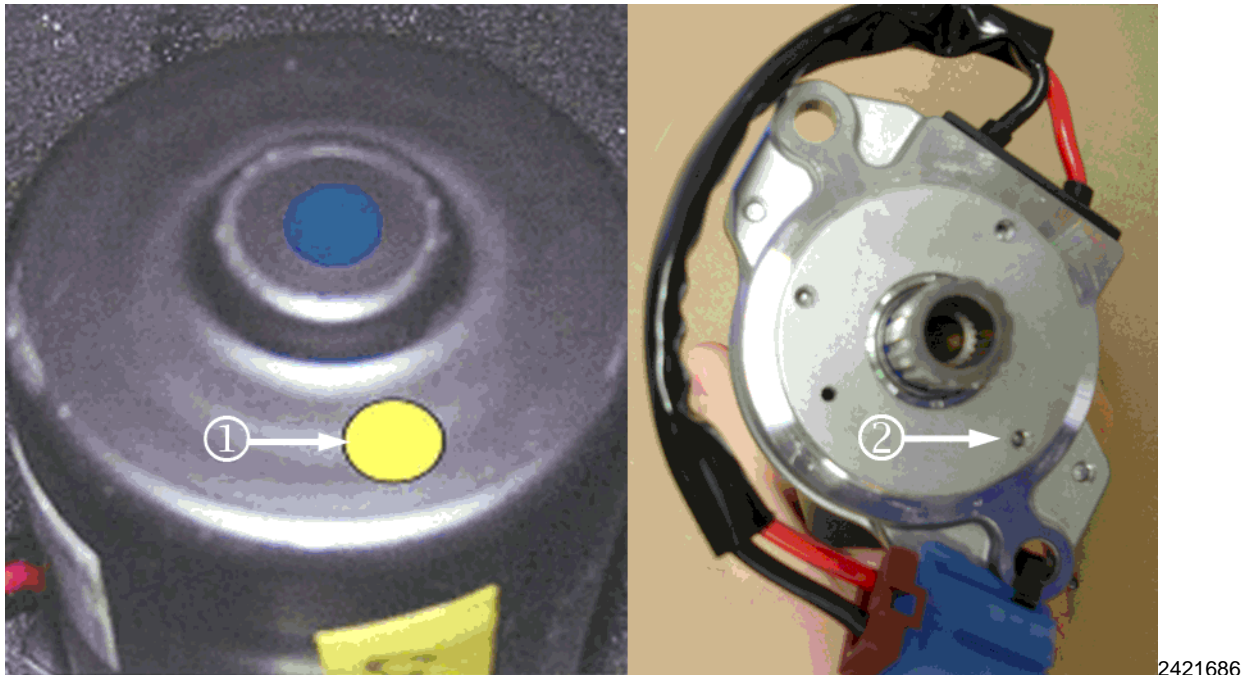
2. Determine what color paint dot is on the bottom side of the EPS motor:
  - If only a blue dot is present then proceed to Step 3 in this inspection procedure.
  - If blue and yellow dot are present then proceed to the *EPS Motor Replacement Procedure* in this bulletin.
  - If only a yellow dot is present then proceed to the *EPS Motor Replacement Procedure* in this bulletin.
  - If only a pink dot is present then proceed to the *EPS Motor Replacement Procedure* in this bulletin.
  - If only a green dot (remanufactured) is present, then proceed to the *EPS Motor Replacement Procedure* in this bulletin.
3. Locate the EPS motor screw hole (2). Refer to the illustration.

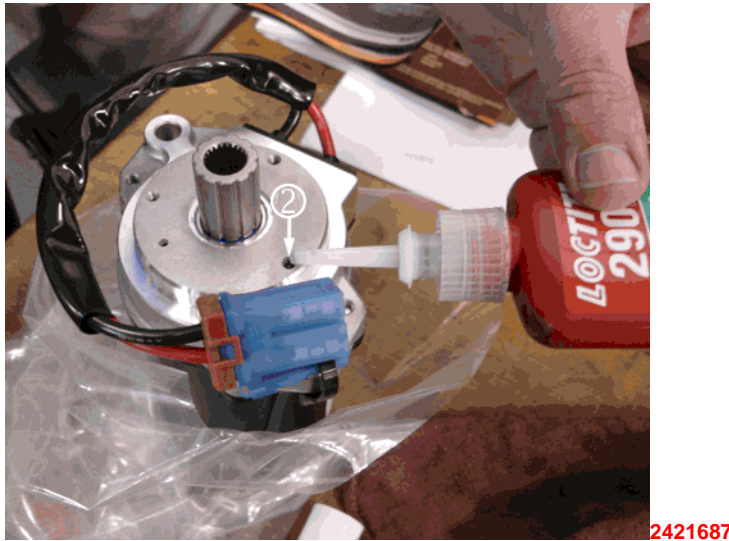
**Caution: To avoid part damage, ensure that Loctite 290 is applied to the EPS motor BEFORE it is installed. Only apply the Loctite in the hole as indicated in the illustration. DO NOT apply Loctite to any other hole.**

4. Apply Loctite 290 (P/N 29031) to the EPS motor screw hole (2). Wipe away any excess Loctite. Allow the Loctite to cure for 1 minute.
5. Using a yellow marker, place a yellow dot (1) on the bottom side of the EPS motor as shown in the illustration.
6. Proceed to the *EPS Motor Replacement Procedure* below.
