File In Section: Product Recalls
Bulletin No.: 10023B
Date: June 2010

PRODUCT SAFETY RECALL

SUBJECT: Loss of Power Steering Assist – Replace Electric Power Steering Motor

MODELS: 2005-2010 Chevrolet Cobalt
2005 Pontiac Pursuit
2005-2006 Pontiac G4
2006 Pontiac G5 Pursuit
2007-2010 Pontiac G5
Equipped with Electric Power Steering

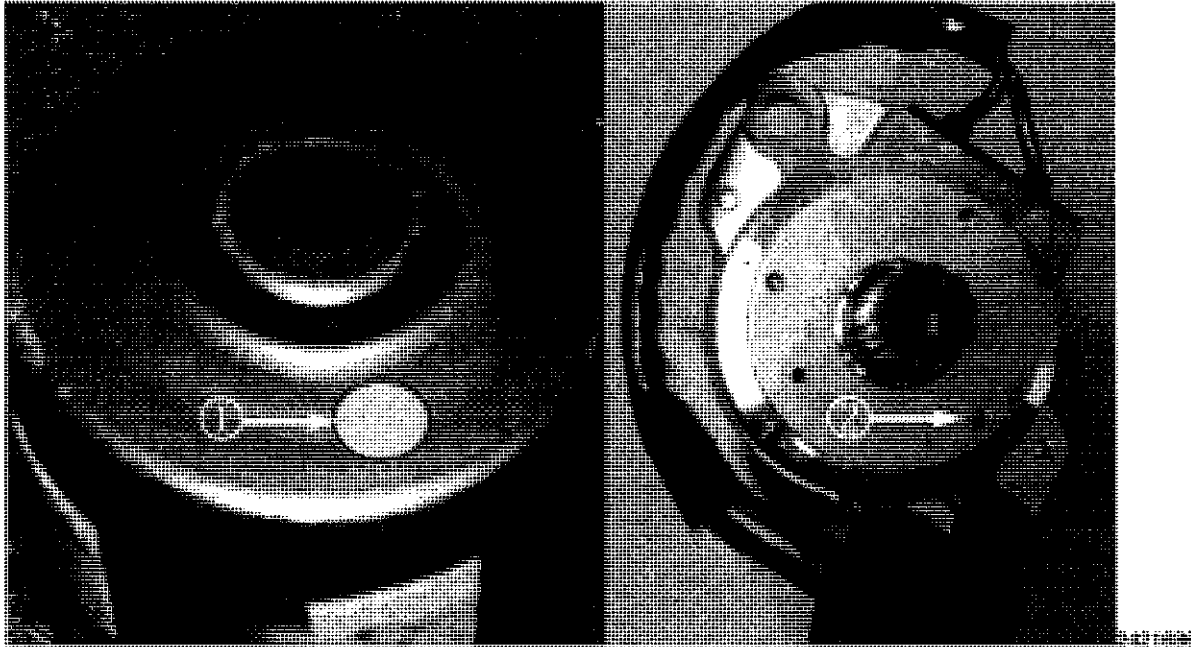
2. Determine what color paint dot is on the bottom side of the EPS motor:
 - If only a blue dot is present then proceed to Step 3 in this inspection procedure.
 - If blue and yellow dot are present then proceed to the *EPS Motor Replacement Procedure* in this bulletin.
 - If only a yellow dot is present then proceed to the *EPS Motor Replacement Procedure* in this bulletin.
 - If only a pink dot is present then proceed to the *EPS Motor Replacement Procedure* in this bulletin.
3. Locate the EPS motor screw hole (2). Refer to the illustration.
