Recall Bulletin

PRODUCT SAFETY RECALL

SUBJECT: Loss of Power Steering Assist – Replace Electric Power Steering Motor

MODELS: 2005-2010 Chevrolet Cobalt
2005 Pontiac Pursuit
2005-2006 Pontiac G4
2006 Pontiac G5 Pursuit
2007-2010 Pontiac G5
Equipped with Electric Power Steering

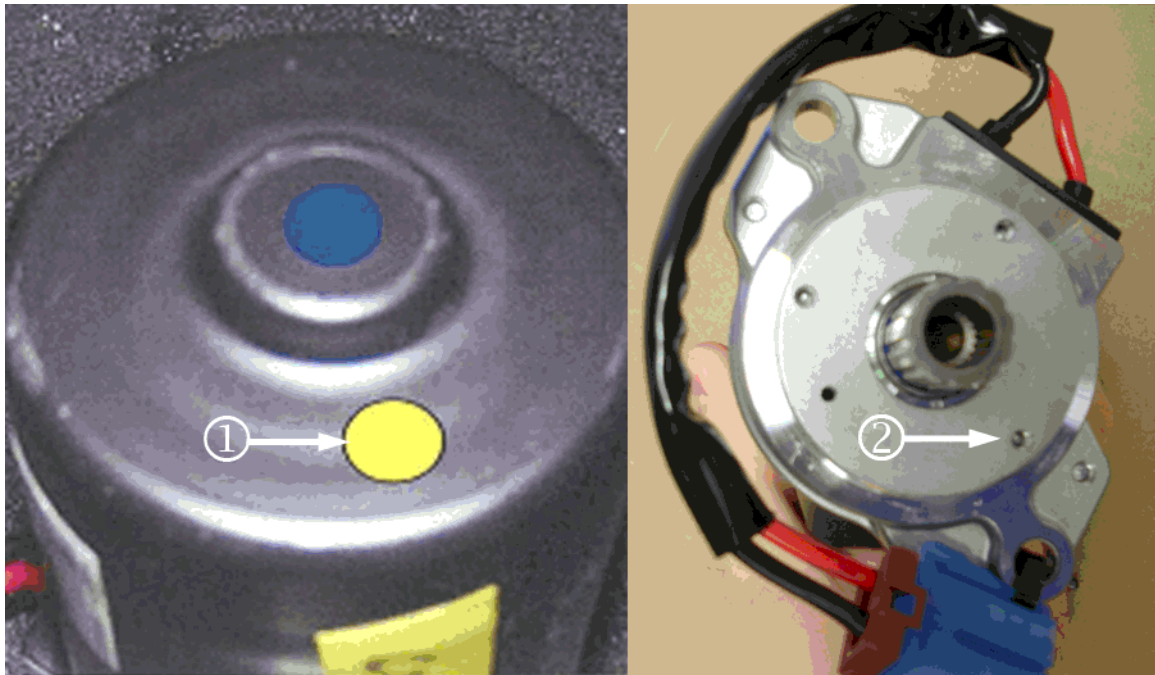
2421686

1. Remove the EPS motor from kit P/N 20930092.
2. Determine if the bottom side of the EPS motor has a yellow dot.
 - If a yellow dot (1) **IS** present, proceed to the *EPS Motor Replacement Procedure* in this bulletin.
 - If a yellow dot (1) **IS NOT** present, proceed to Step 3 in this inspection procedure.

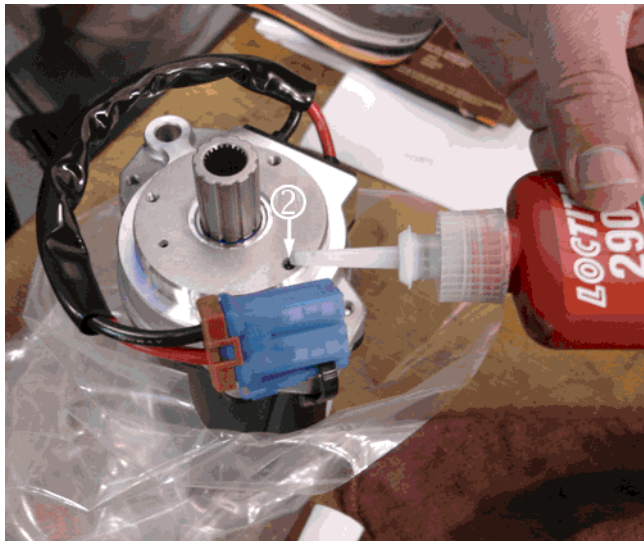
2421687

3. Locate the EPS motor screw hole (2). Refer to the illustration.

Caution: To avoid part damage, ensure that Loctite 290 is applied to the EPS motor BEFORE it is installed. Only apply the Loctite in the hole as indicated in the illustration. DO NOT apply Loctite to any other hole.

4. Apply Loctite 290 (P/N 29031) to the EPS motor screw hole (2). Wipe away any excess Loctite. Allow the Loctite to cure for 1 minute.
5. Using a yellow marker, place a yellow dot (1) on the bottom side of the EPS motor as shown in the illustration.
6. Proceed to the *EPS Motor Replacement Procedure* below.
