# RECALL CAMPAIGN BULLETIN

NTB10-037

## VOLUNTARY SAFETY RECALL CAMPAIGN 2005 – 2009 ARMADA AND TITAN FUEL GAUGE INACCURACY

**CAMPAIGN ID #:** R1010  
**NHTSA #:** 10V-074  
**APPLIED VEHICLES:** 2005 – 2009 Armada (TA60)  
2005 – 2009 Titan (A60)

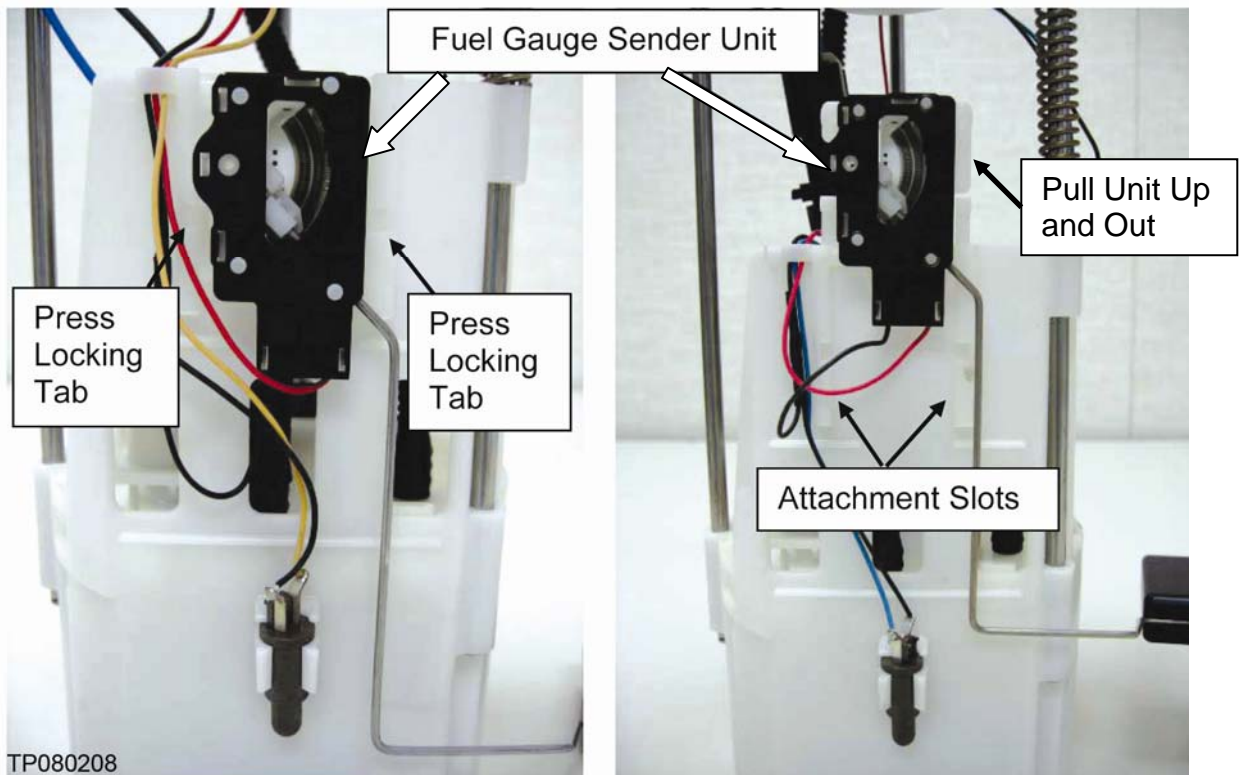
**With Type B Float Arm**

1. Remove the Fuel Pump Assembly from the vehicle.
  - Refer to section FL in the applicable Service Manual for removal information.
  - Make sure to follow all Service Manual warnings and cautions.
2. Remove the Fuel Gauge Sender Unit from the Fuel Pump Assembly as follows:
  - a. First, press in on the two locking tabs on the sides of the Fuel Gauge Sender Unit
  - b. Then, pull the unit UP and OUT of the attachment slots
    - For Type A see Figure 1
    - For Type B see Figure 2 on the next page.

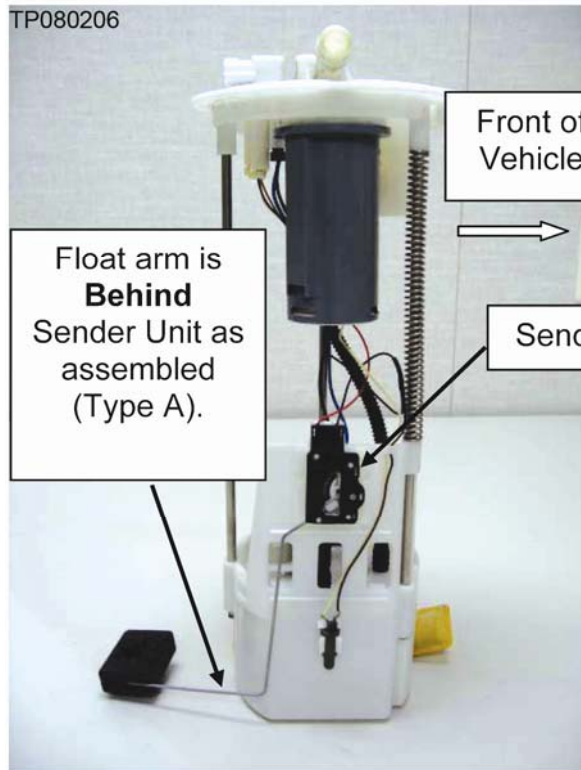
Figure C

**Type A Float Arm**

\*\* There are two types of float arms (Type A and Type B). Refer to Figures C and D on the next page. The orientation of the new replacement float arm (float arm type) must be the same as the original.

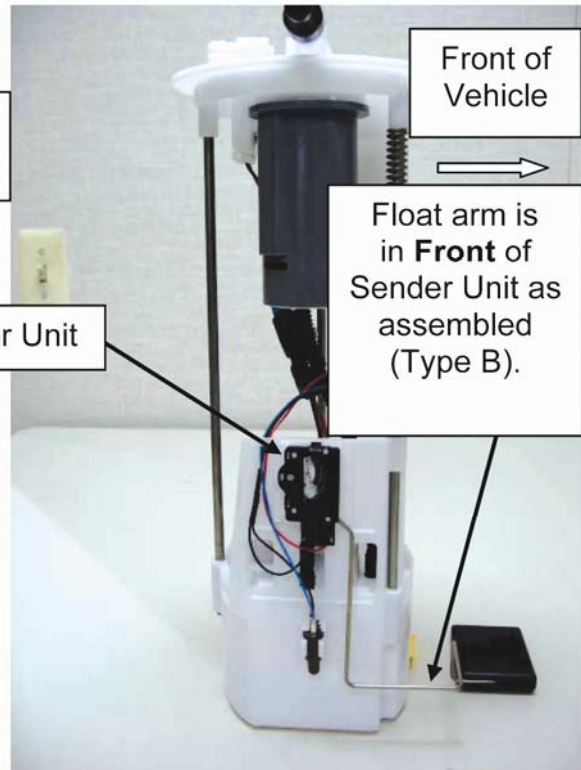
Figure D

**Type B Float Arm**
