ITB10-020

VOLUNTARY SAFETY RECALL CAMPAIGN 2005 – 2009 QX56 FUEL GAUGE INACCURACY

CAMPAIGN ID #: R1011
NHTSA #: 10V-074
APPLIED VEHICLES: 2005 – 2009 QX56 (JA60)

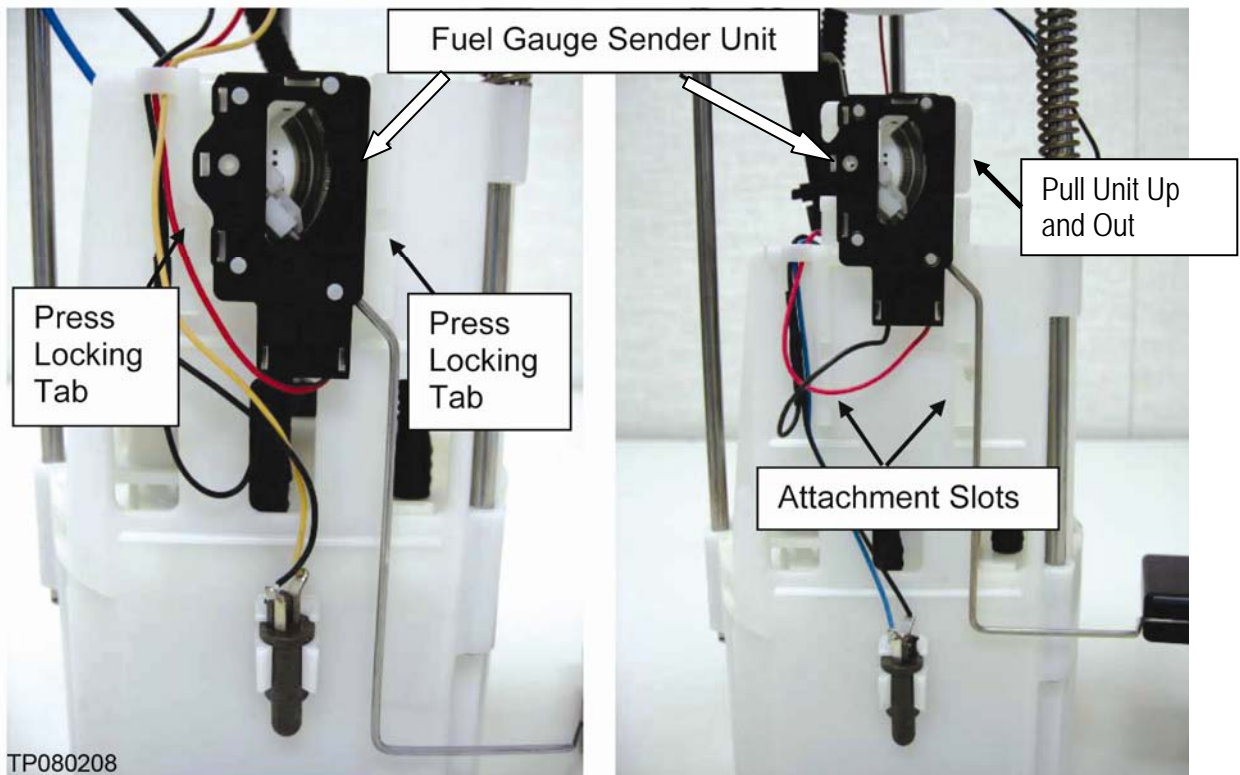
With Type B Float Arm

1. Remove the Fuel Pump Assembly from the vehicle.
 - Refer to section FL of the applicable Service Manual for removal information.
 - Make sure to follow all Service Manual warnings and cautions.
2. Remove the Fuel Gauge Sender Unit from the Fuel Pump Assembly as follows:
 - a. First, press in on the two locking tabs on the sides of the Fuel Gauge Sender Unit
 - b. Then, pull the unit UP and OUT of the attachment slots
 - For Type A see Figure 1
 - For Type B see Figure 2 on the next page.
