Applies To: **2007 Element** – ALL
2008 Element 2WD – From VIN 5J6YH1...8L000001 thru 5J6YH1...8L015906
2008 Element 4WD – From VIN 5J6YH2...8L000001 thru 5J6YH2...8L018137
2007-08 Odyssey – ALL

May 14, 2010

Safety Recall: Air In VSA Modulator-Control Unit Causes Low/Soft Brake Pedal (Supersedes 10-017, dated April 17, 2010, to revise the information marked by the black bars)

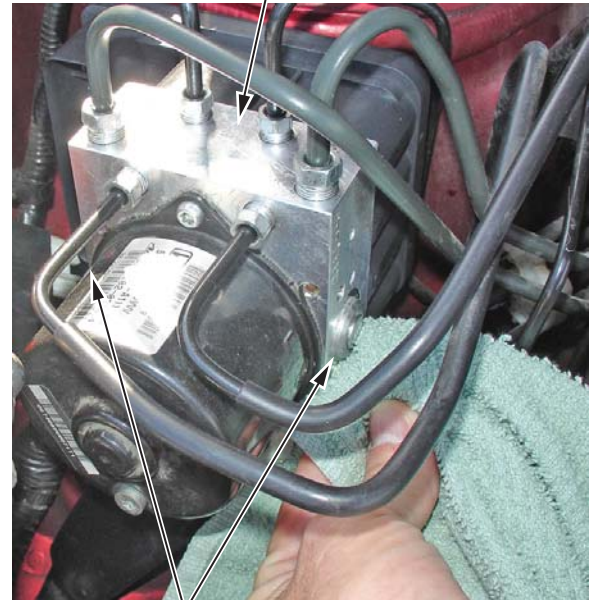
VSA MODULATOR-CONTROL UNIT

Clean the plugs on both sides.

9. Moisten a clean shop towel with isopropyl alcohol, then use the towel to thoroughly clean the two plugs and the surrounding areas on the sides of the VSA modulator-control unit. Allow the alcohol to dry before you continue.

NOTE: If there is corrosion on or near the modulator plugs, remove it with a scouring pad, then thoroughly clean the area with a shop towel moistened with isopropyl alcohol. Allow the alcohol to dry before you continue.
