Applies To: **2007 Element – ALL**

2007–08 Odyssey – ALL

April 13, 2010

Safety Recall: Air In VSA Modulator-Control Unit Causes Low/Soft Brake Pedal

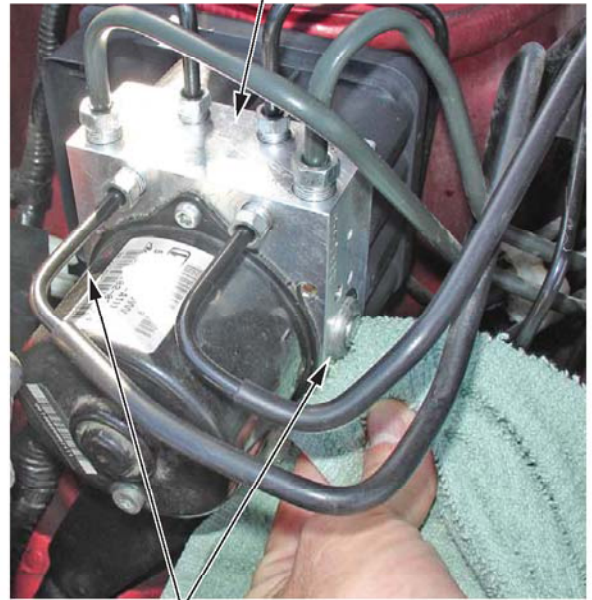
VSA MODULATOR-CONTROL UNIT

Clean the plugs on both sides.

9. Moisten a clean shop towel with 99% isopropyl alcohol, then use the towel to thoroughly clean the two plugs and the surrounding areas on the sides of the VSA modulator-control unit. Allow the alcohol to dry before you continue.

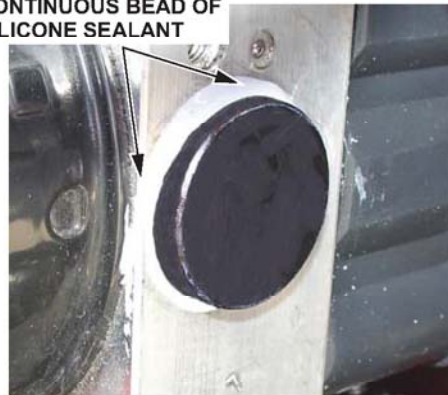
CONTINUOUS BEAD OF SILICONE SEALANT

- The cap should fit squarely on the plug, flush to the modulator body.
- Make sure there's a continuous bead of silicone sealant around the cap.
- If any sealant runs from the cap, wipe off the run, but do not wipe off the cap.
- If the sealant gets on any other parts, wipe it off immediately.
