10V-108

**PRODUCT CAMPAIGN BULLETIN**

**APPLICABILITY:** 2010 Tribeca  
**SUBJECT:** Front Door Latch Cable

**NUMBER:** WVO-25  
**DATE:** March 2010

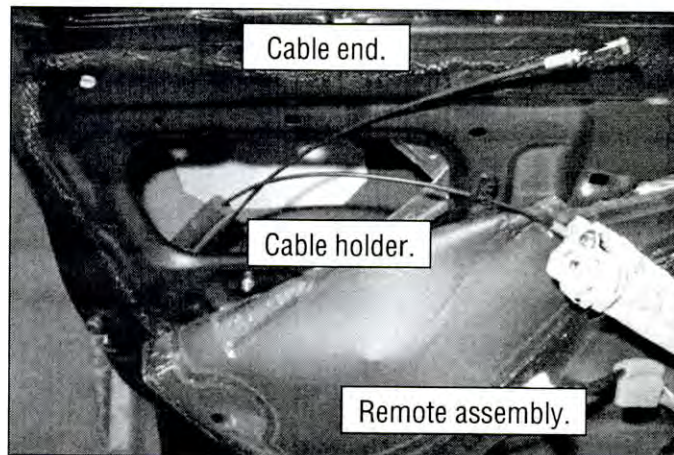
Subaru of America, Inc. has determined that certain 2010 Tribeca models may have been produced with door latch cables (located inside the vehicle's driver and front passenger doors) that were improperly positioned. As a result, a cable can catch in the door glass regulator when a window is opened or closed. Should that occur, it may unlatch the door, causing it to come open unexpectedly when the window is raised or lowered.

- 10) Remove the screw that secures the remote assembly and slide the assembly back to detach it from the door. Remove the upper cable from the cable holder and cable end from the remote assembly. Re-route the upper cable and position it behind the lower cable. Reinstall the cable end to the remote assembly, snap the cable back into the holder and reattach the remote assembly.
