# RECALL CAMPAIGN BULLETIN

NTB10-049

## VOLUNTARY SAFETY RECALL CAMPAIGN 2010 FRONTIER, XTERRA, AND PATHFINDER STEERING COLUMN POSITIONING BRACKET AND PASSENGER AIR BAG FASTENERS

**CAMPAIGN ID #:** PC045  
**NHTSA #:** 10V-115  
**APPLIED VEHICLES:** 2010 Frontier (D40)  
2010 Xterra (N50)  
2010 Pathfinder (R51)

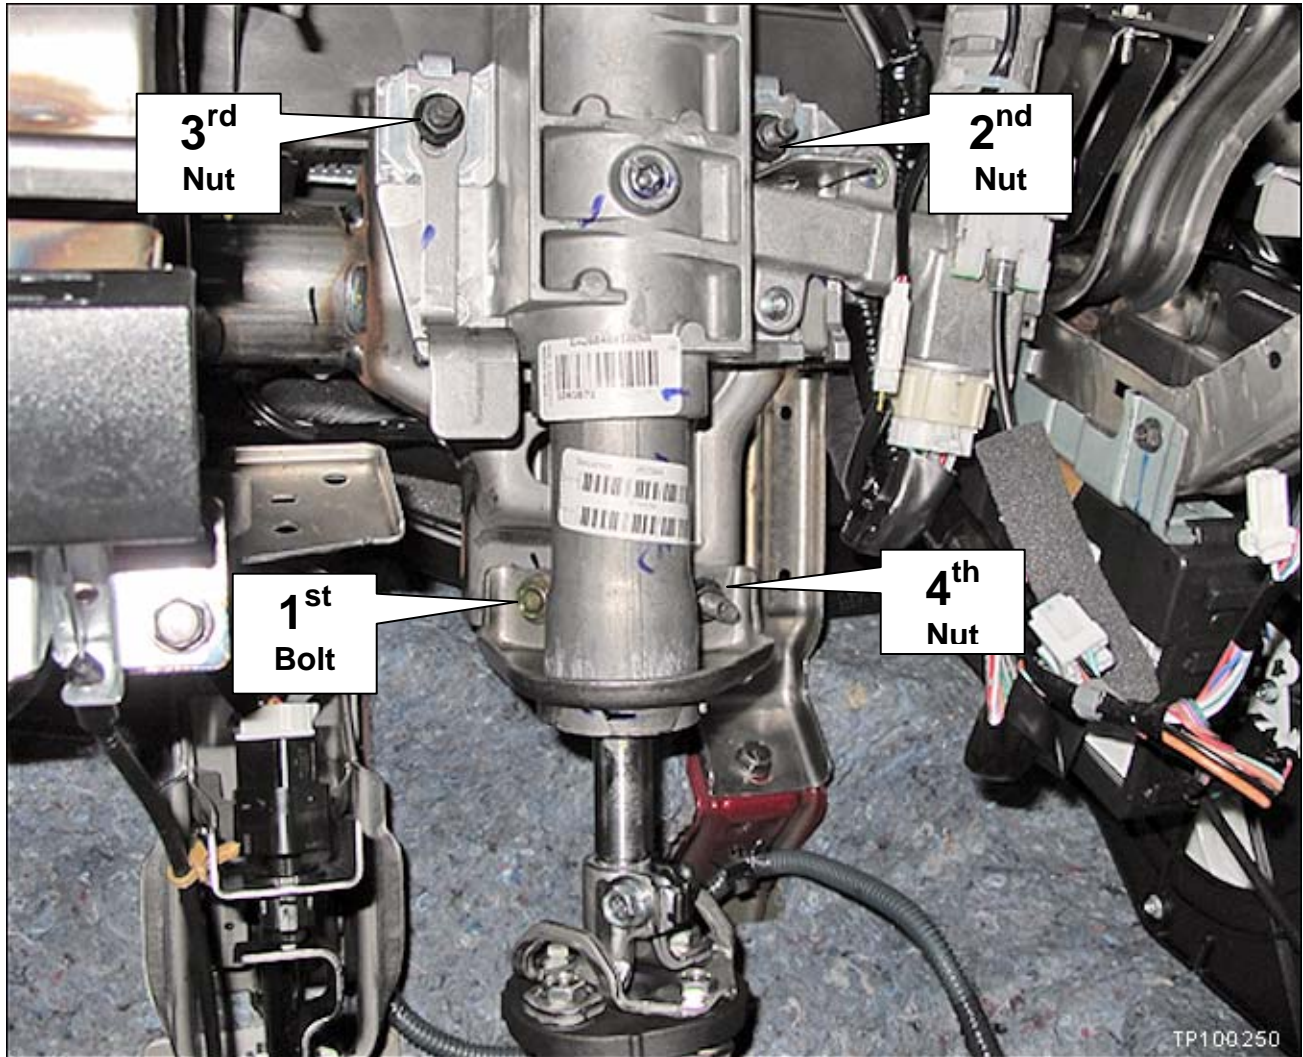
Figure 5

6. Perform a torque check on the steering column fasteners (3 nuts and 1 bolt) shown in Figure 5.
  - a. Set the torque wrench to 16.7 N•m (1.7 kg-m, **12 ft-lb**).
  - b. Look under the dash and locate the fasteners.
  - c. Torque the nuts and bolt in the order shown in Figure 5.

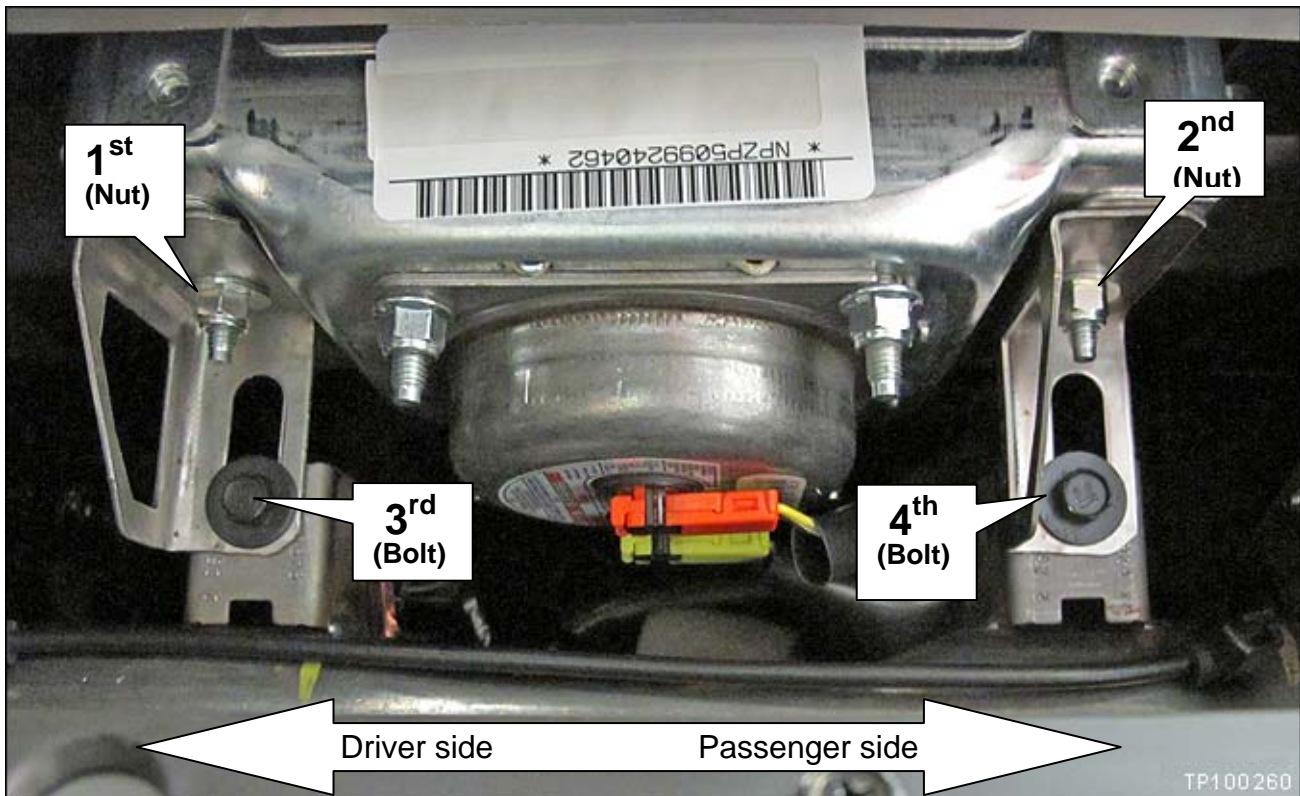
Figure 12

16. Perform a torque check on the passenger air bag fasteners (2 nuts and 2 bolt) as follows (see Figure 12):

- a. Set the torque wrench to 9.4 N•m (0.95 kg-m, **7 ft-lb, 84 in-lb**).
- b. Look under the dash behind the upper glove box to locate the fasteners.
- c. Torque the nuts and bolt in the order shown in Figure 12.

**If ANY nut or bolt turns when checking the torque, do the following:**

A. Loosen the nuts.

B. **Replace** the bolts.

- Use new bolts listed in the parts information.

C. Tighten and torque the nuts and bolt in the order shown in Figure 12.
