EC Series Electrical System Mandatory Product Improvement

Trans/Air Manufacturing maintains a policy of continuous improvement of our products and services. In keeping with this philosophy, Trans/Air is issuing Mandatory Product Improvement 09-002, to address the following key areas of concerns in the aftermarket installation of Trans/Air EC series electrical Climate Control Systems.

Trans/Air has developed a product improvement kit p/n 5031234 for EC2.0 & EC2.5 and kit p/n 5031233 for EC3.0

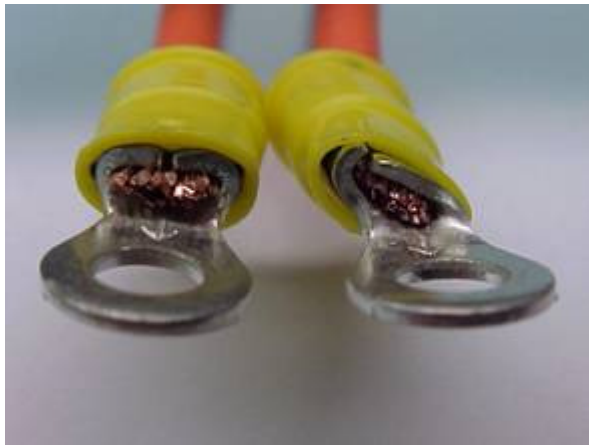
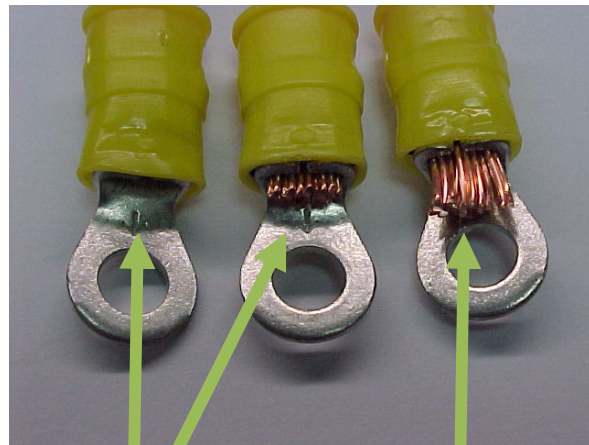
Fig 1

Correct Position

Poor Position In Crimper

Correct

Poor Wire strands Too long

1. Crimps on the wires going to the terminal strip of the relay board should be uniform and tight. There should be no bare wire visible between the wire insulation and the terminal, and strands on the ring end should be cut flush or close to the terminal barrel, so there is no interference under the screw head. (Fig 1 & Fig 2)

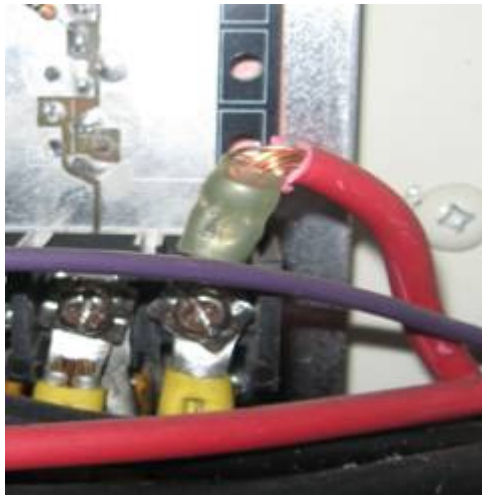
Fig 2

Poor Crimp

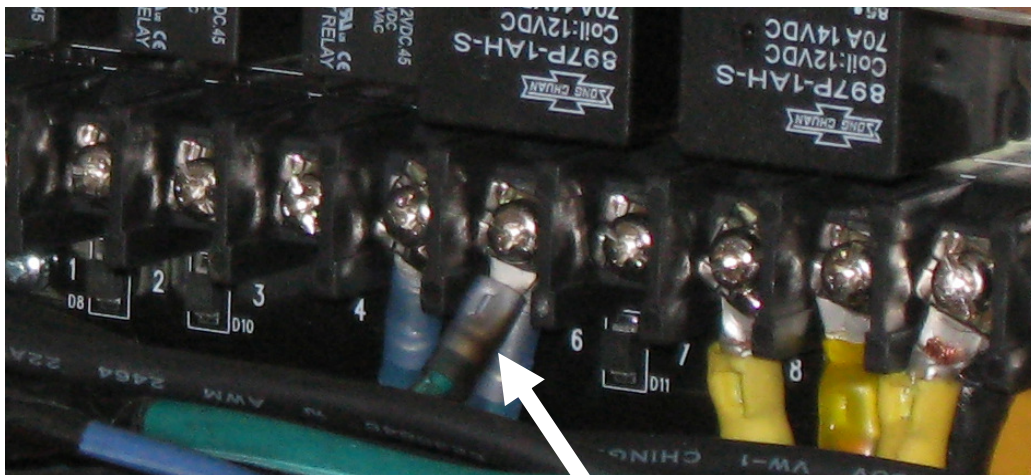
Conductive material on relay board. (Metal shaving etc.) Loose wire terminal screws at the relay board, or improper crimps

Fig 4**Heat discoloration of a poor (loose) crimp**

4. EC2.0/2.5 - Inspect the board overall. Look for any discoloration or evidence of heat. Inspect the area in front of, and above the EC2.0/2.5 relay board. If there are any refrigerant hoses laying against the board or directly above the board, please contact Trans/Air for a relay board cover to eliminate any chance of condensate contacting the relay board. Hoses that may be near the board must be secured properly, to eliminate movement toward the relay board.
